**Fire Investigation Report 382-17
Kings Dock Car Park
Monarch Quay
Liverpool**

Compiled by Station Manager *****
Incident Investigation Team, Merseyside Fire and Rescue Service.

FIRE INVESTIGATION

PREMISES: Kings Dock Car Park, Monarch Quay,
Liverpool

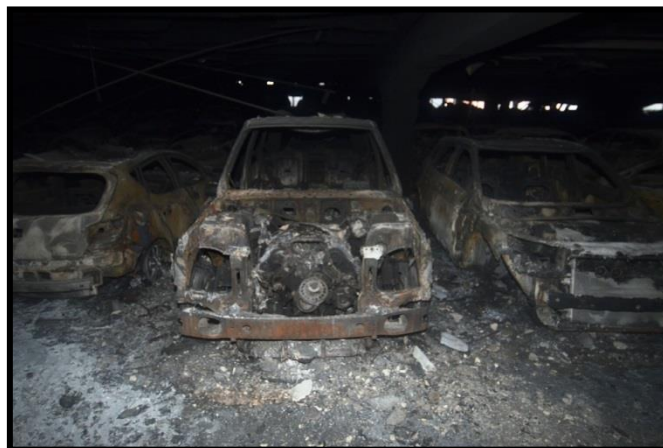
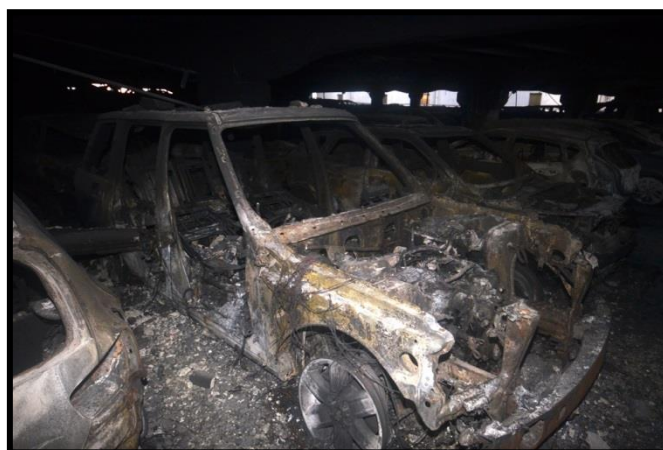
Fig 6 and 7. Show vehicle originally involved in fire

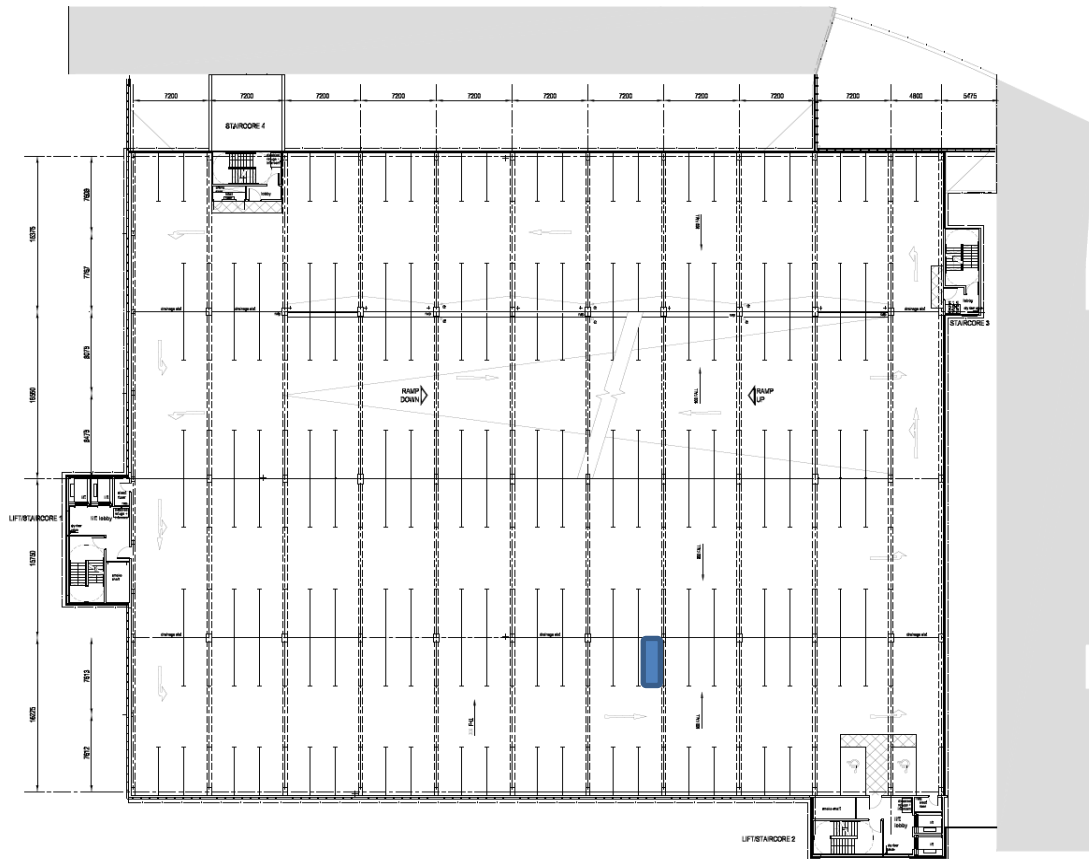
13 PLAN OF LEVEL 3

Location of vehicle first involved in fire

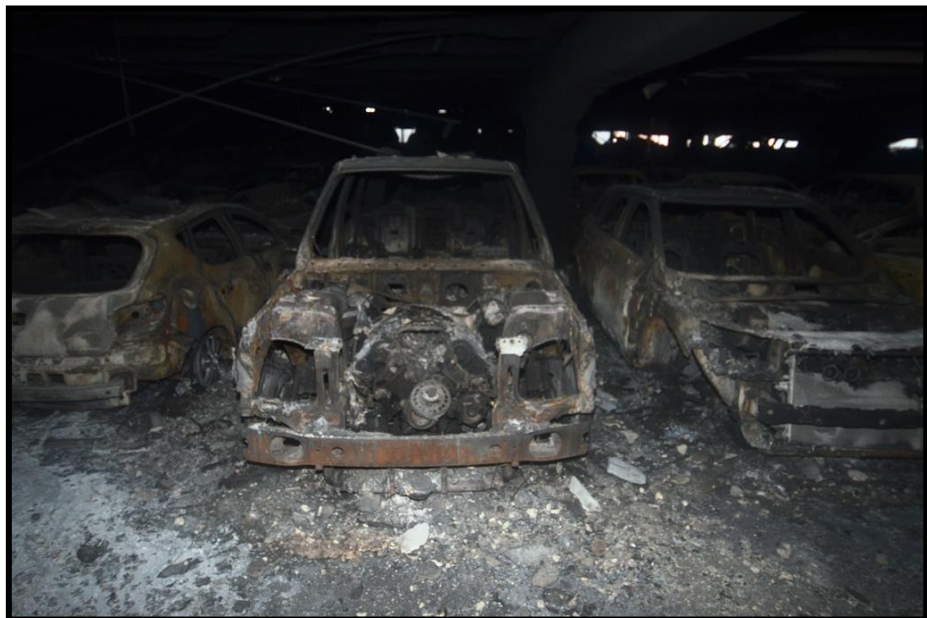
1

Vehicle originally involved in fire

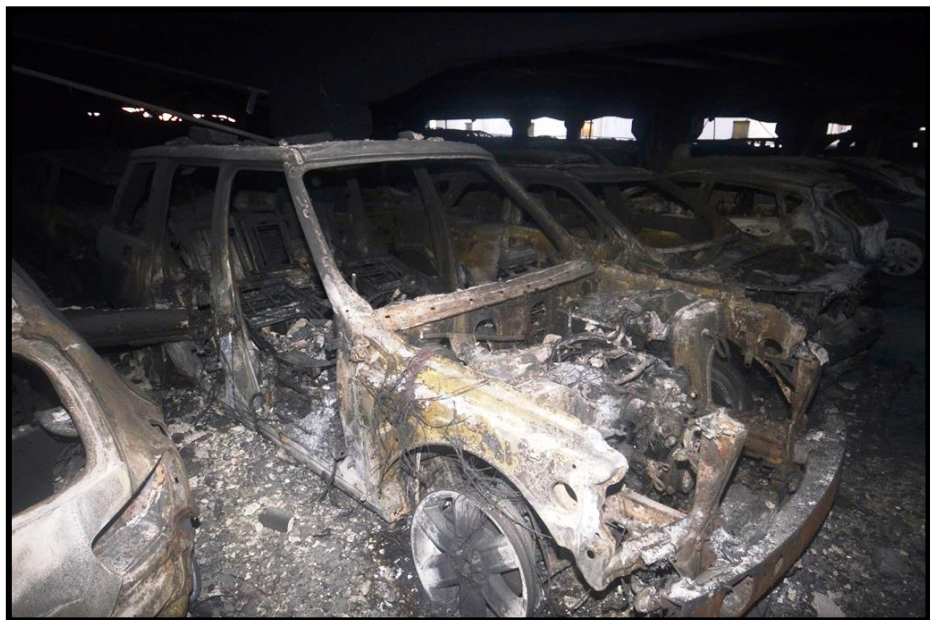
2

Offside view of vehicle

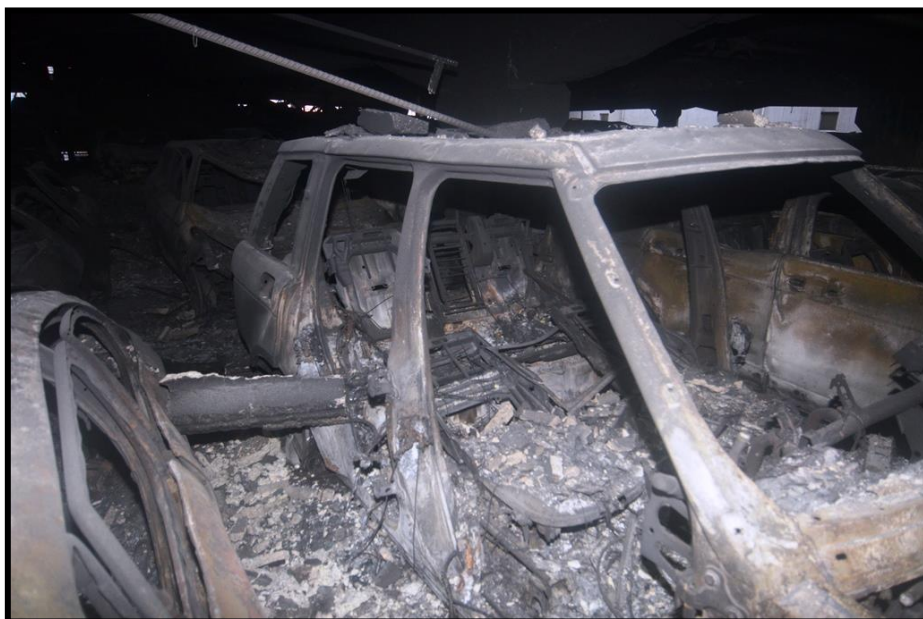
3

parked. It is more than likely that the fire started accidentally, either due to an electrical fault or a component failure.

Close up of fire damage to vehicle that first caught fire

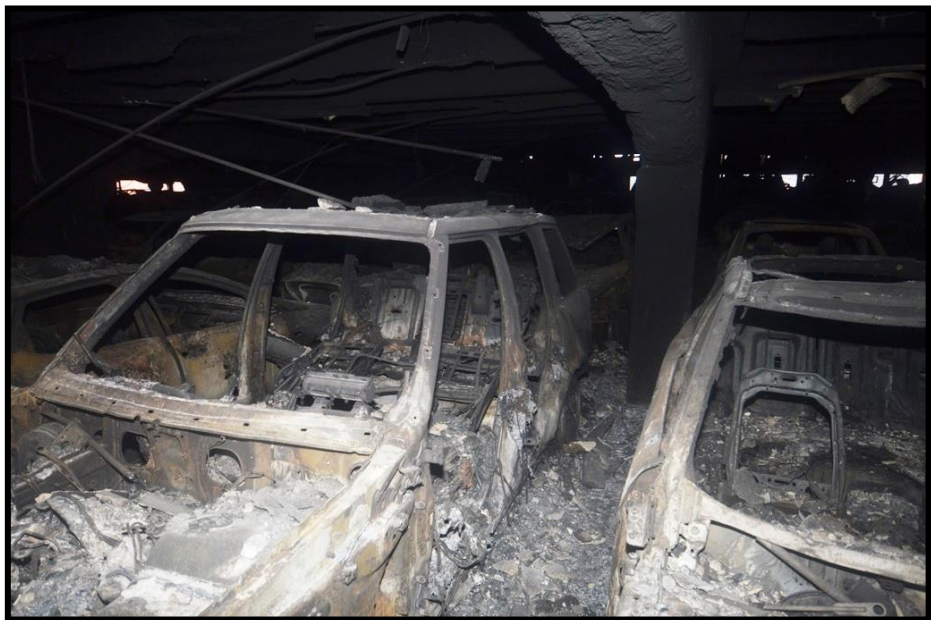
4

Nearside view of vehicle

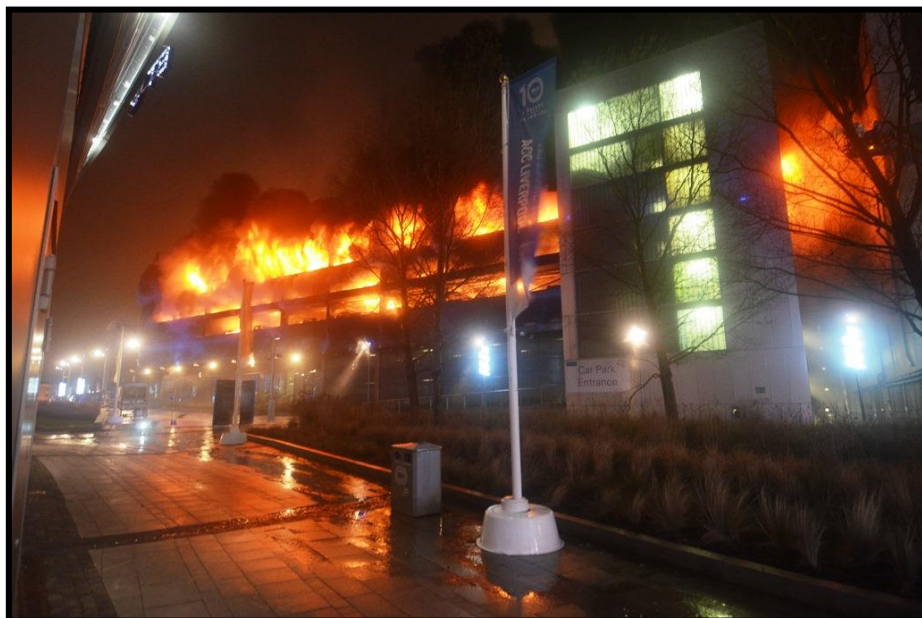
5

View of fire from Pullman Hotel

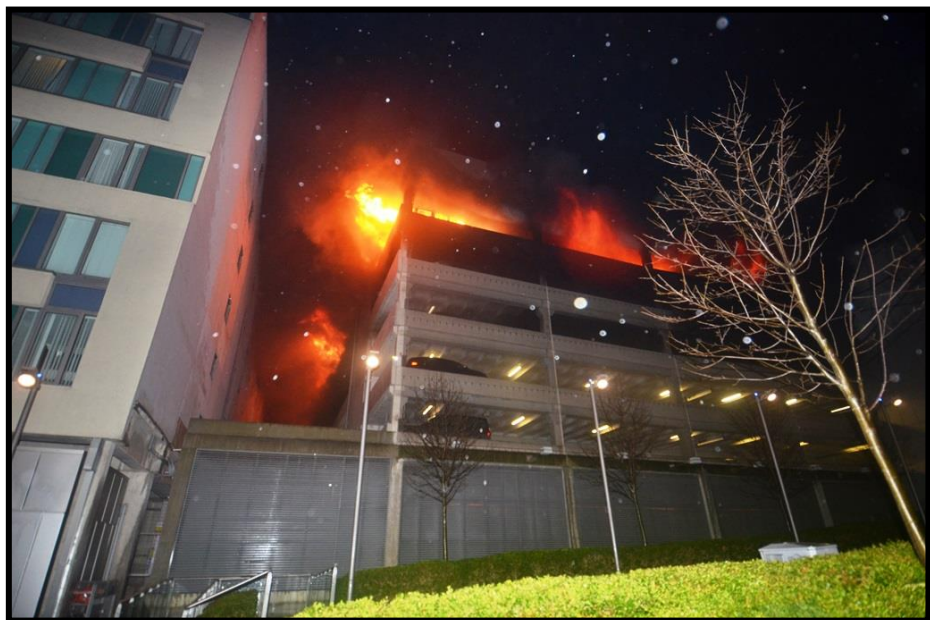
6

View of fire from opposite main entrance to car park

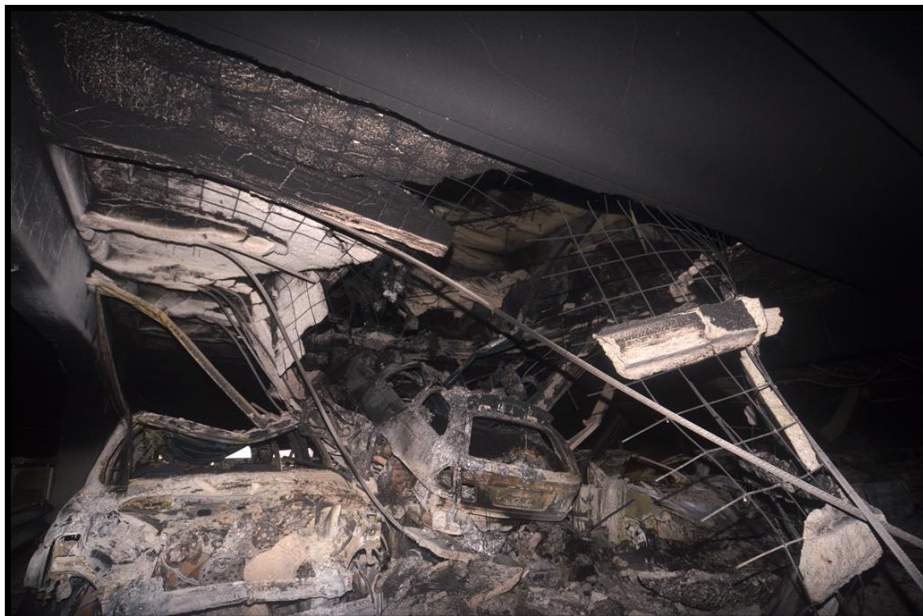
7

Failure of concrete as a result of the fire

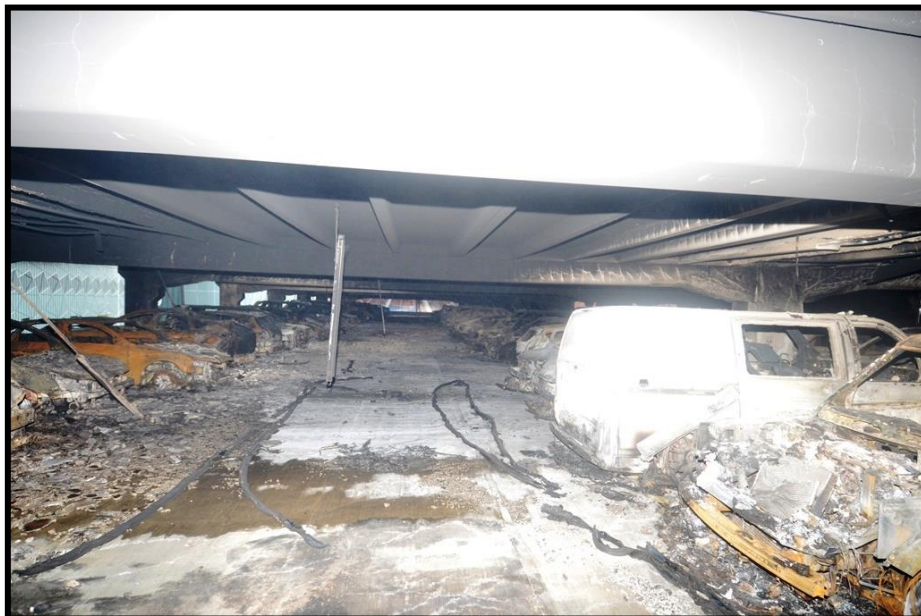
8

Fire damaged vehicles on level 3 in area where fire started

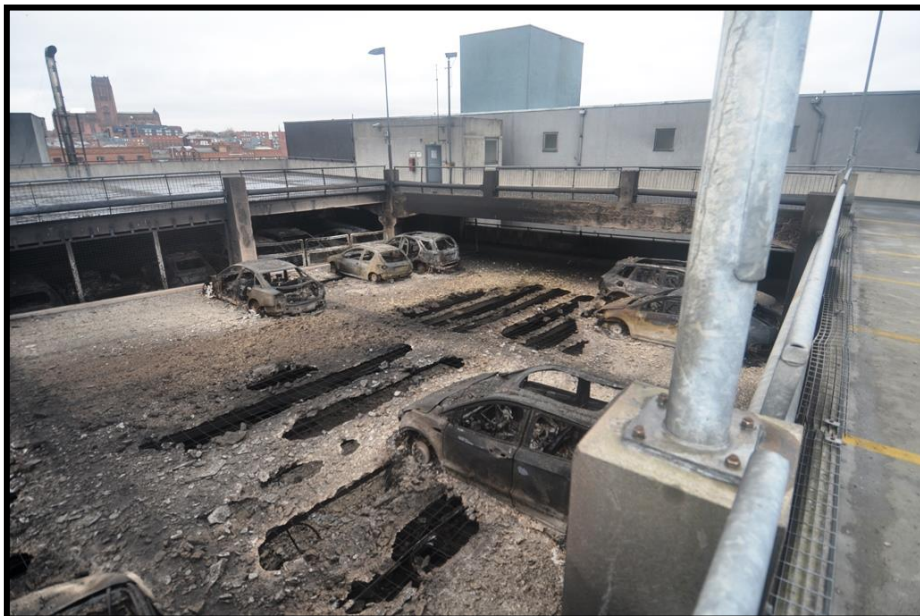
9

Fire damage on ramp leading to level 7
