KINGS DOCK CAR PARK FIRE

PROTECTION REPORT

April 2018

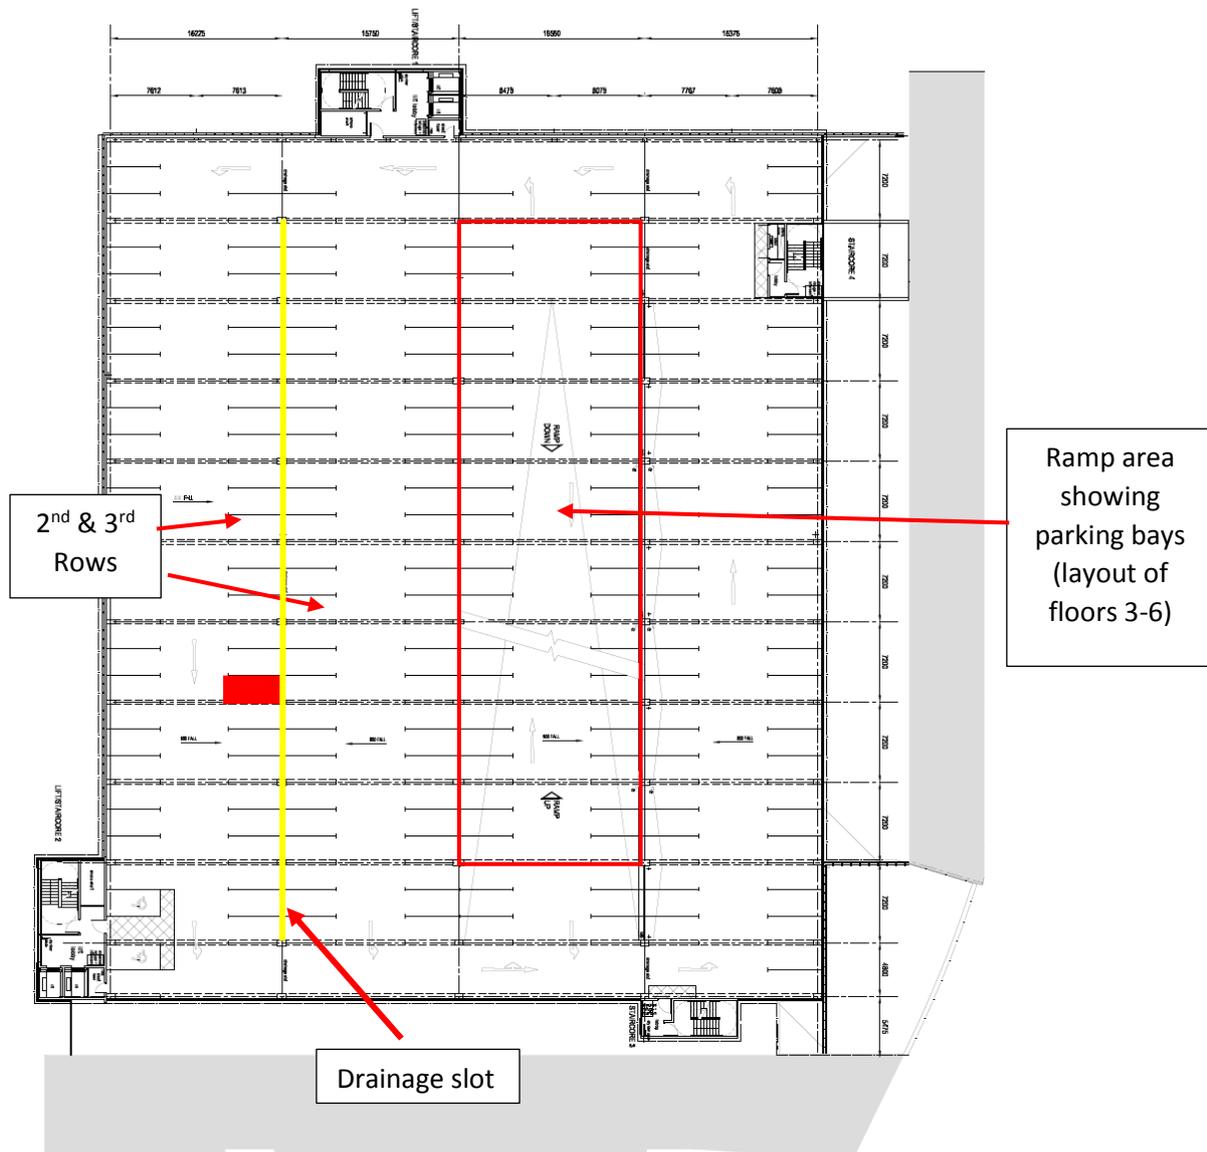
Figure 2.1.1: Level 3-6 floor plan with drainage and ramp system

From initial observations, CCTV and open Social Media sources it could be seen that the fire, once sufficiently developed, moved rapidly up through the structure. Early thoughts around this concentrated on vehicles being parked on the ramps between floors as a possible factor in fire spread.

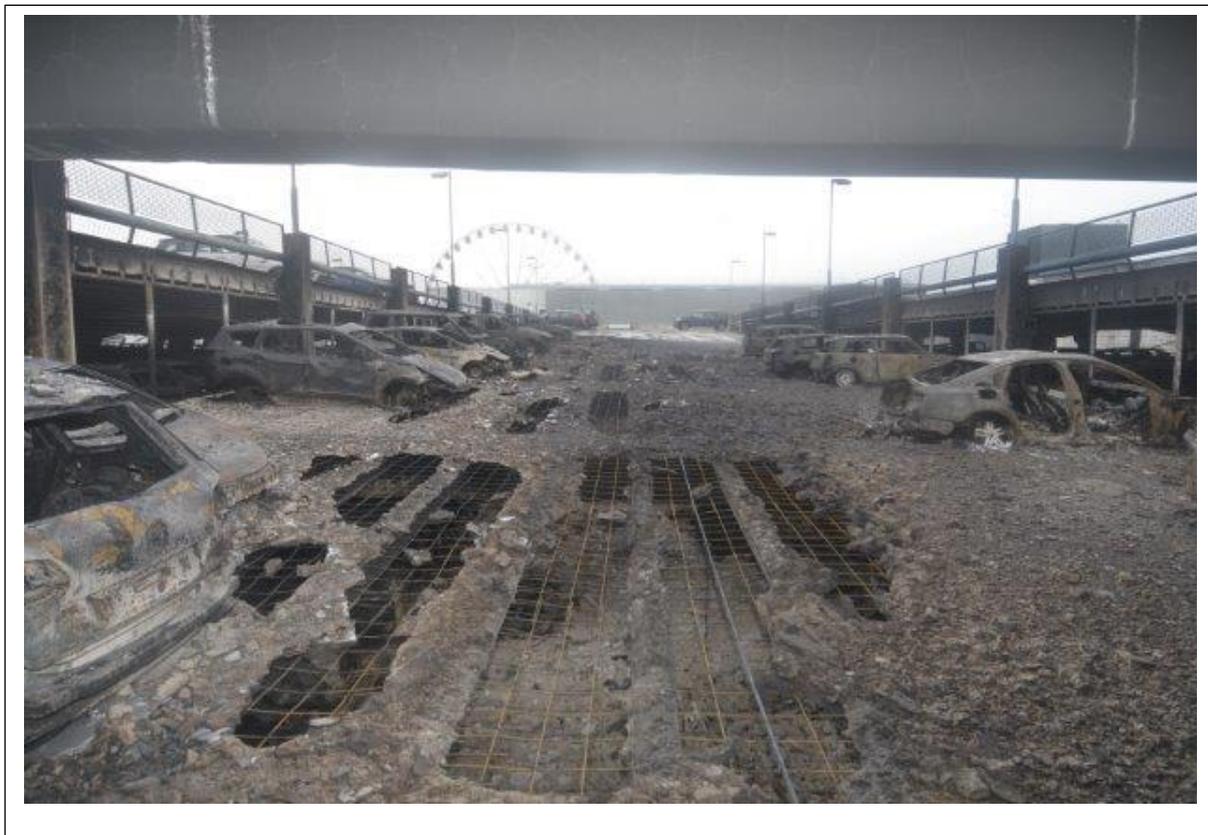
Figure 2.1.2: Photograph of ramp from level 6 to level 7

BA teams and external firefighting personnel had reported spalling or exploding concrete, with BA teams seeing debris falling down from the ceilings on level 3. The later BA teams also reported holes in the ceiling on level 3 and ignited fuel running down like a waterfall from the floor above.

The explosive spalling of the concrete, particularly of the precast ribbed floor slab, may have provided an additional route for fire development between levels. However, the fire severity for this event to occur would be well in excess of the fire design resistance period. The integrity of the concrete and its resistance to spalling will depend on many factors, such as water content; whether the concrete is reinforced and the aggregate and materials used.

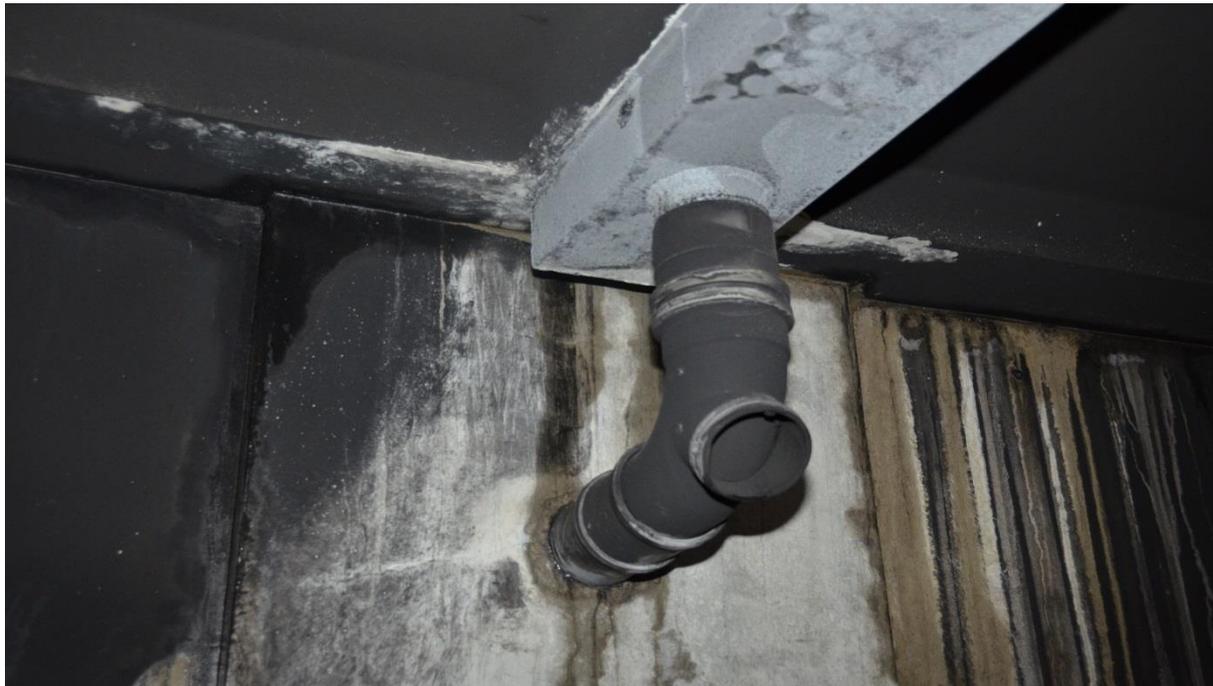
Figure 2.2.1: Photograph of intact drainage system type adjacent to vehicle of origin

This is considered as the likely cause of initial fire spread between level 3 and 4.

1. Fire may spread beyond floor of origin. In the case of Kings Dock evidence would suggest that this was initially through the failure of the drainage system and was later exacerbated by the failure of the ribbed slab floor. Although the geometry and central ramp design, combined with running fuel fires, certainly contributed at a later stage in the incident. Designers should give serious consideration to the implications of drainage design that could aid fire spread between levels.

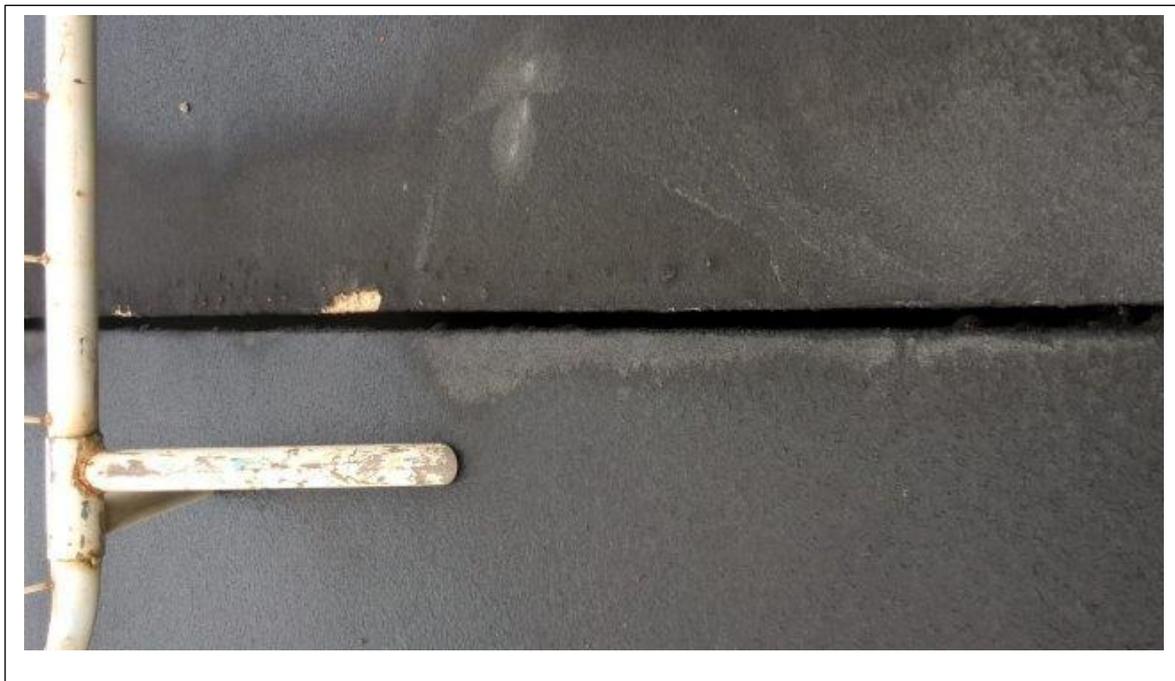
Figure 2.2.2: photo view of the drainage slot from above, Level 7 Roof

This drainage slot runs between columns with two rows of three cars parked between each column (see fig.2.1).

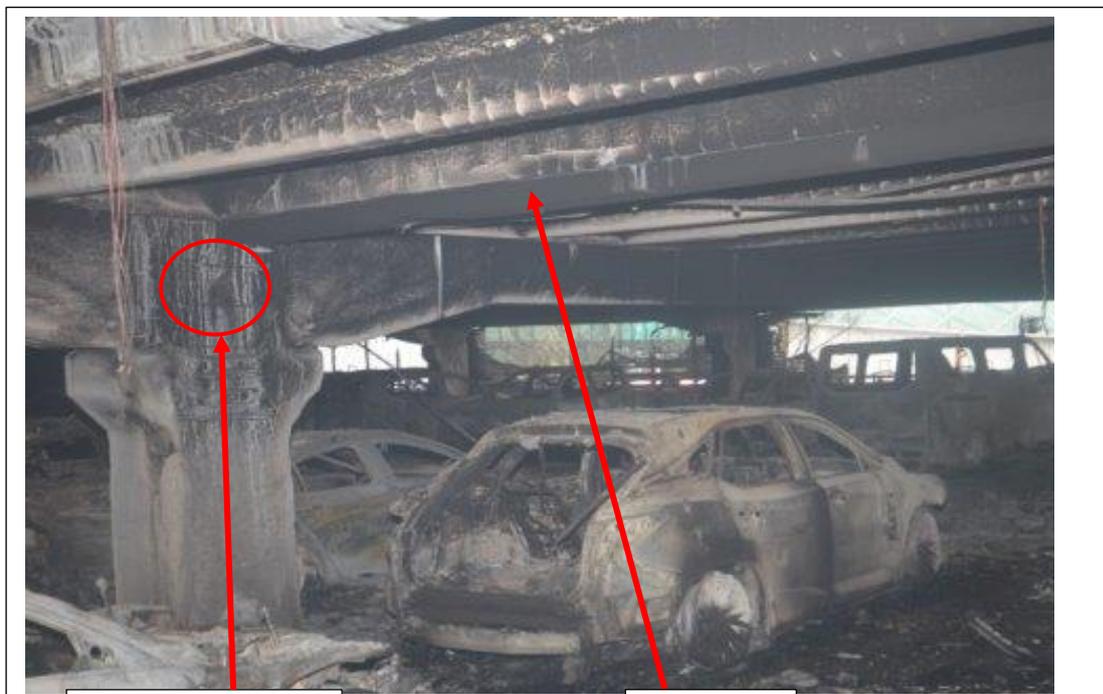
Figure 2.2.4: section of aluminium guttering in place.

Plastic drainpipe elbow burnt away.

Aluminium guttering

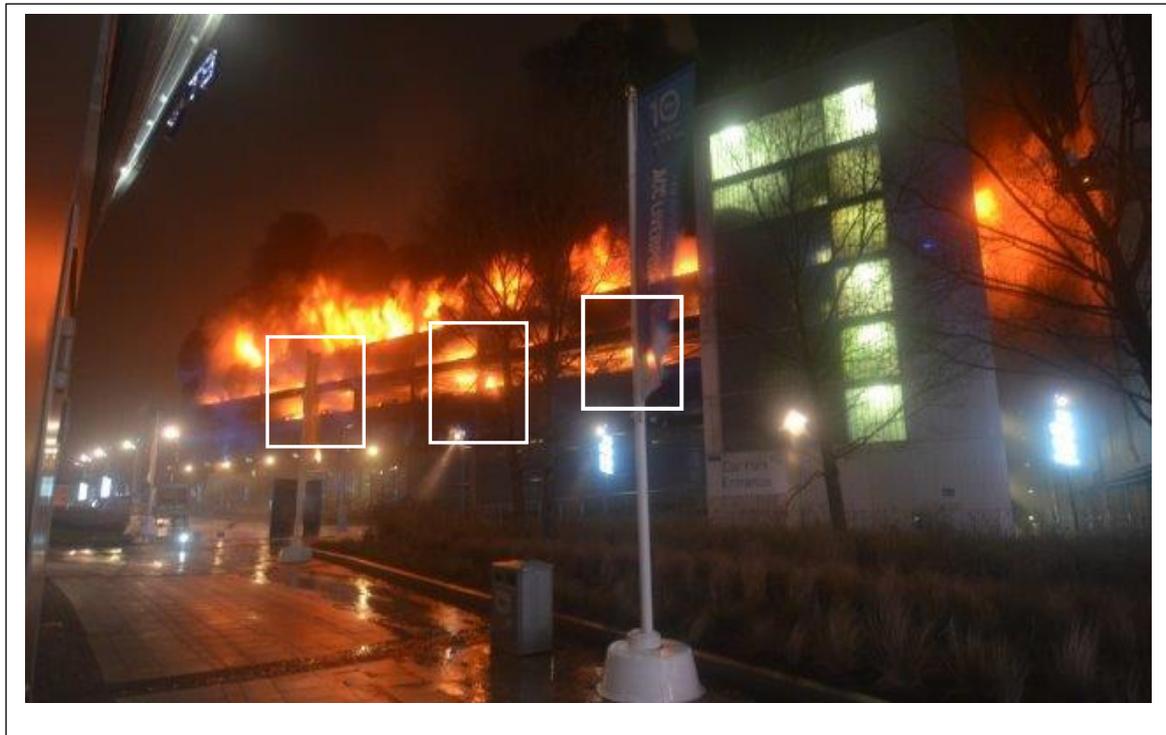
Figure 2.2.5 External CCTV image

The external CCTV image below (**fig.2.2.5**) appears to show vertical walls of fire at equidistant positions along the length of the level. This would appear to be further evidence of drainage failure and the “waterfalls of fire” that BA crews alluded to.

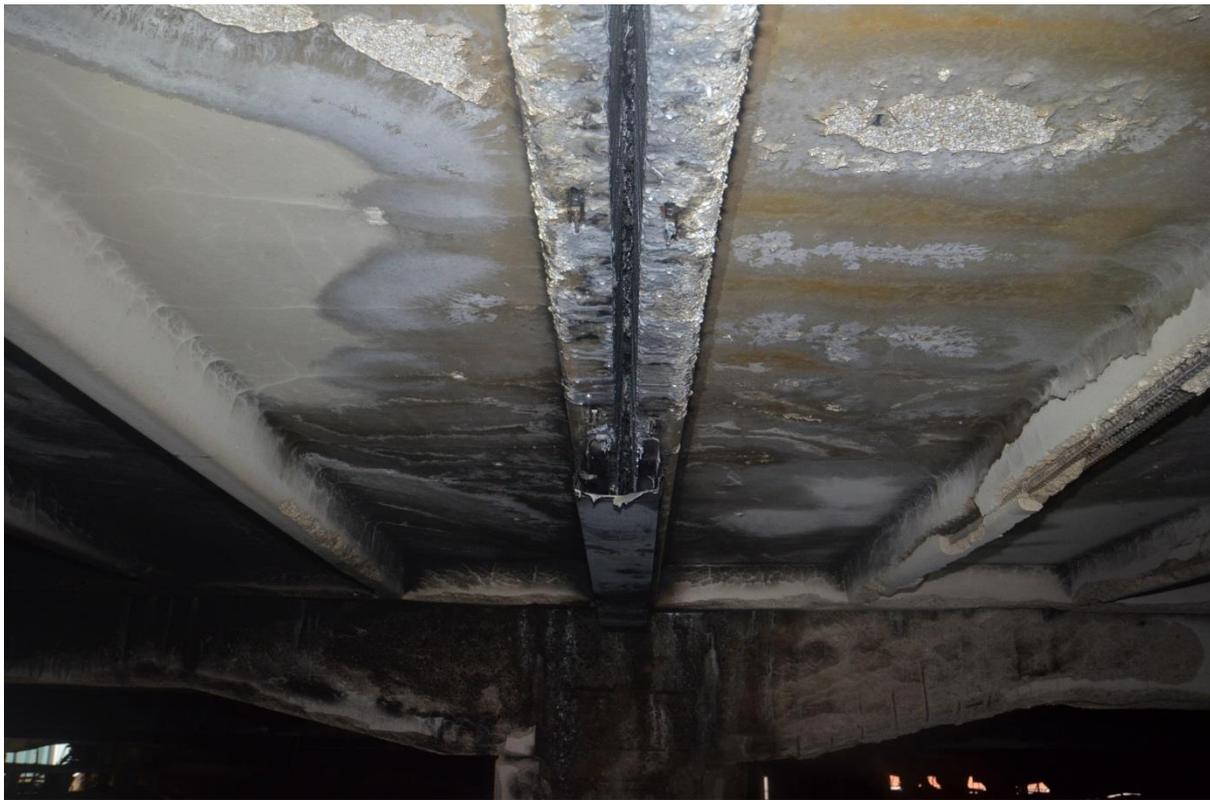
Figure 2.2.6: melted aluminium drainage tray and visible drainage slot

With temperatures in excess of 1,200°C, very early failure of plastic elbow pipes would have occurred and with a melting point of 660°C, the aluminium drainage trays would also have been subject to failure (**see fig.2.2.6**) prior to the spalling of the concrete ribbed floor slabs. Failure of the aluminium tray would expose the drainage channel and allow hot gases and flame to be directed to the floor above and impinge on the two rows of cars adjoining this channel.

A section of undamaged drainage tray from the car park has undergone testing by BRE. This has confirmed it to be 2mm thick aluminium, which would fail at around 660°C.

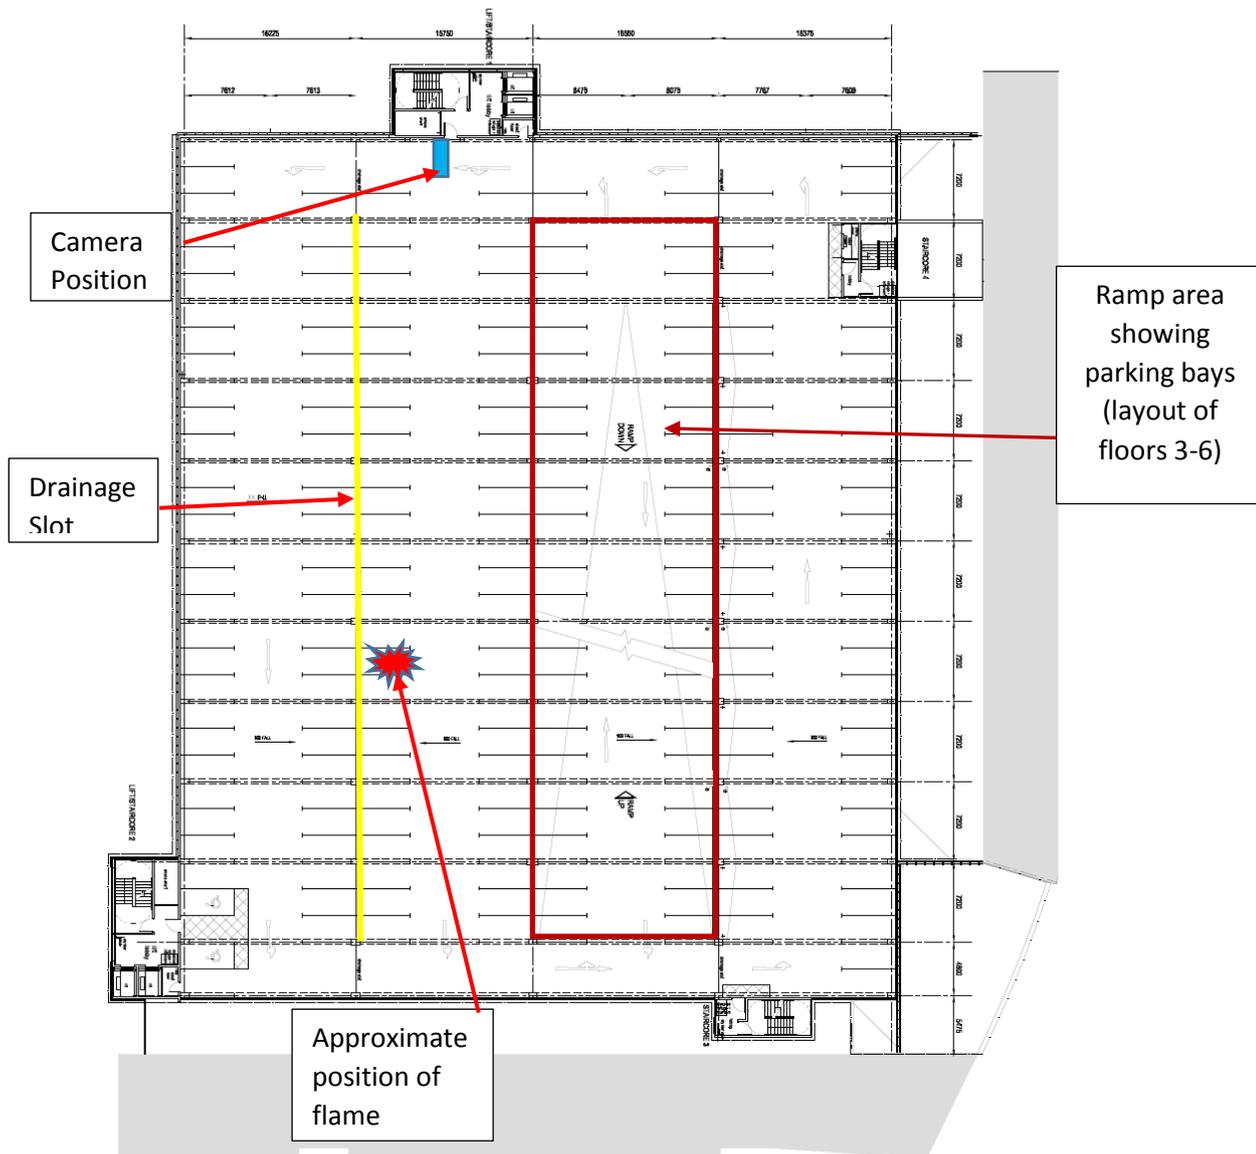
Figure 2.3.1: Level 4 floor plan and position of fire break through

The following plan and images show the first signs of flame captured by CCTV camera outside stairwell 1, level 4 at 17:53hrs (**figure 2.3.2**) and then a well-developed fire at 18:11hrs (**figure 2.3.3**), with several vehicles involved. A major fire event occurred on level 4 shortly afterwards and fire crews were withdrawn for firefighter safety.

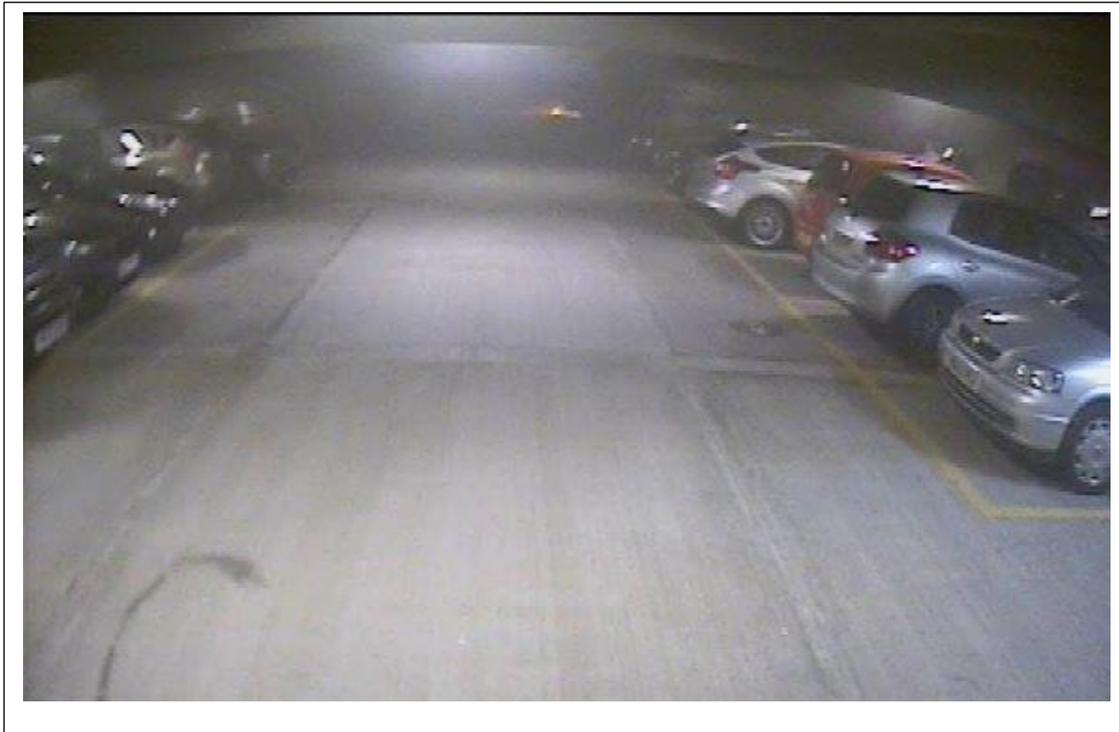
Figure 2.3.2: First Sign of Flames on level 4 at 17:53hrs

This evidence is further proof that the fire spread occurred through the floor, via the drainage system, as the flame is practically directly above where the original fire started. None of the cars adjacent to the ramp are involved in fire at this point. The images showing fire development on level 4 also mirror, to a great extent, the BRE experiments conducted between 2006 and 2009, where multiple vehicles become totally involved in fire in a short period of time, approximately 20 minutes after first ignition.

NB flames may have been present on level 4 earlier than 17:53 but they were not captured by CCTV due to smoke obscuration. Firefighters on level 3 had reported “waterfall of fire” at 17:35, when they returned to BA entry control point.

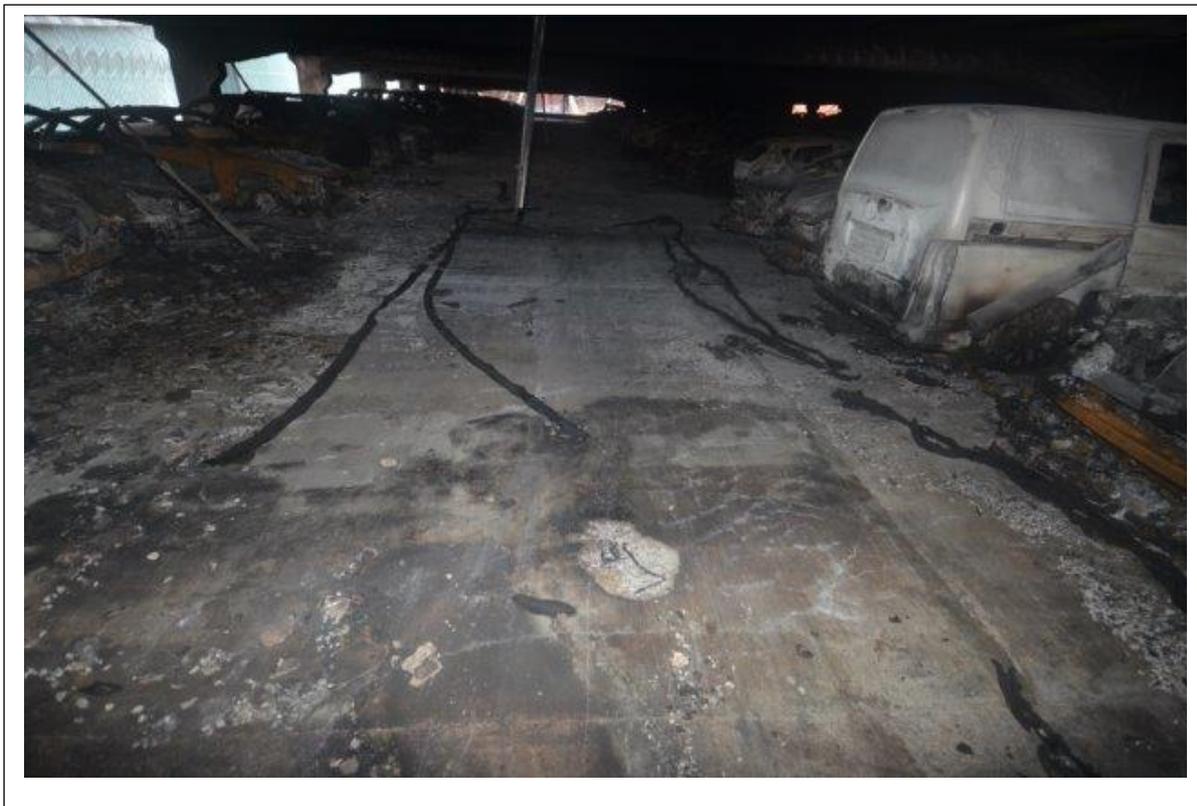
Figure 2.4.1: Photograph of Spalled Concrete: Level 3

Areas of the roadways within the car park, sited away from any parked vehicles, appear to have suffered spalling.

The image above appears to show a distinct difference in surface temperature of the concrete on level 3. The different colouring and the spalling of the floor towards the bottom of the photograph, combined with the two lines of burnt delivery hose, having been vaporised beyond the line of colouration change, would appear to support evidence of very high localised temperatures. In the early stages of the incident, wind direction was coming north easterly (coming towards the camera view for this photograph) and firefighters had to withdraw from this area due to the untenable conditions.

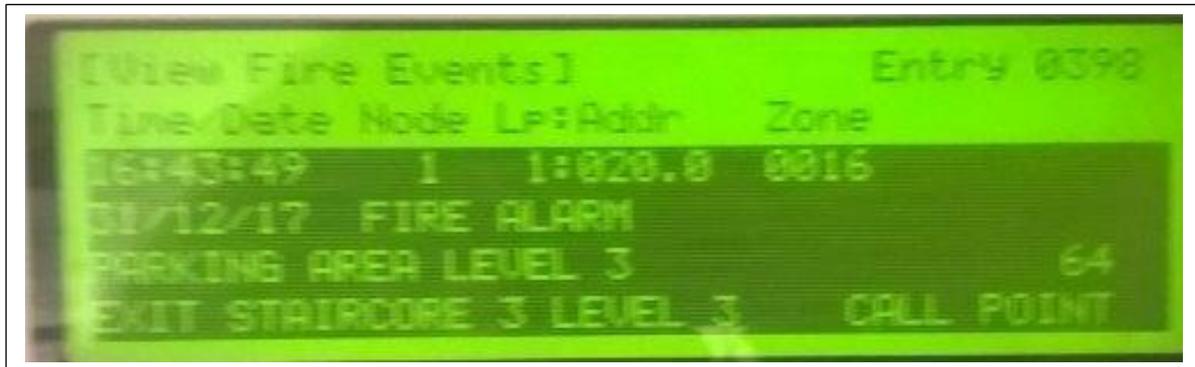
Figure 3.4.2: Photograph of Alarm Panel, 1st Actuation

The fire alarm was first actuated at 16:43:49, alarm panel indicating call point 64, level 3, adjacent to escape stairwell 3.

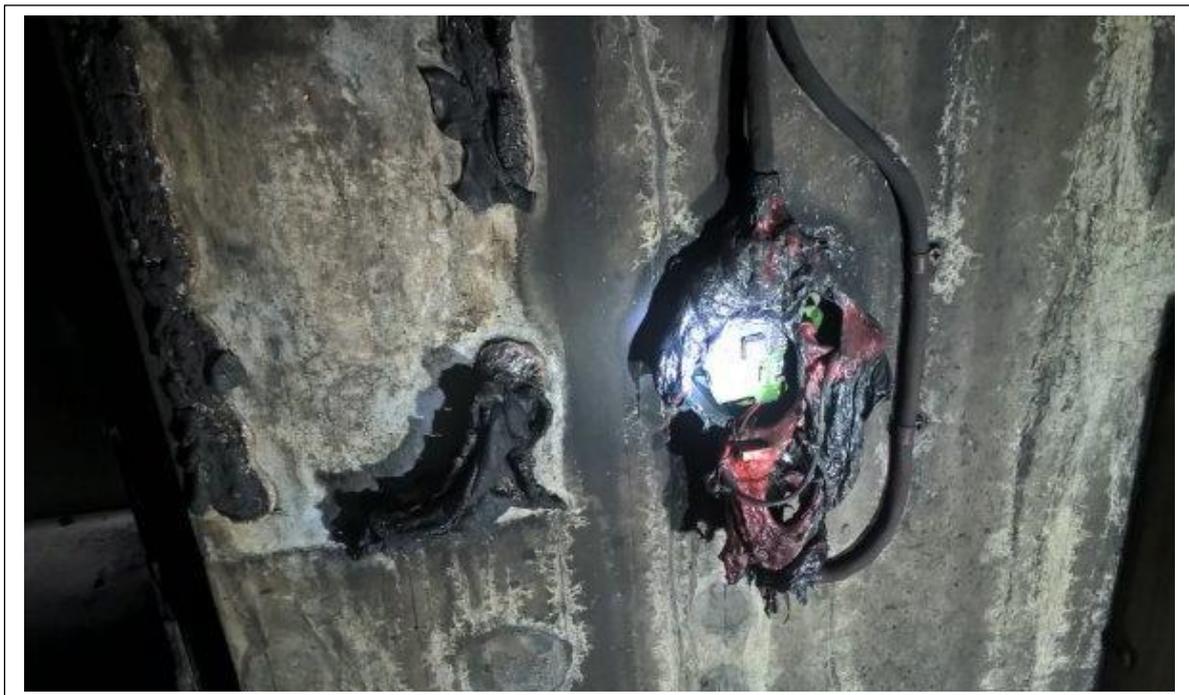
Figure 3.4.3: Photograph of Damaged Call Point on Level 3, Outside Stairwell 3

However, it was not possible to visually identify this call point, due to fire damage.

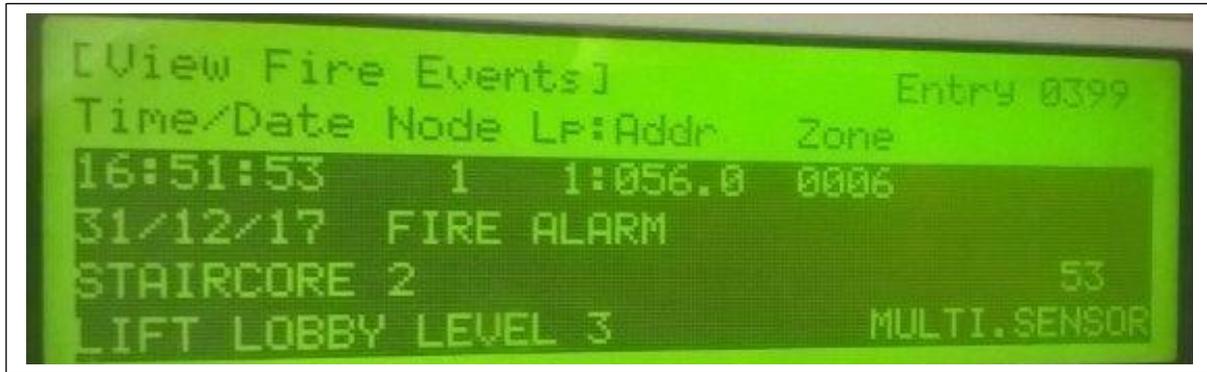
Figure 3.4.4: Photograph of Alarm Panel, 1st Actuation

The second actuation was at 16:51:53, alarm panel indicating multi-sensor 53. The fire alarm panel indicates lift lobby, level 3.

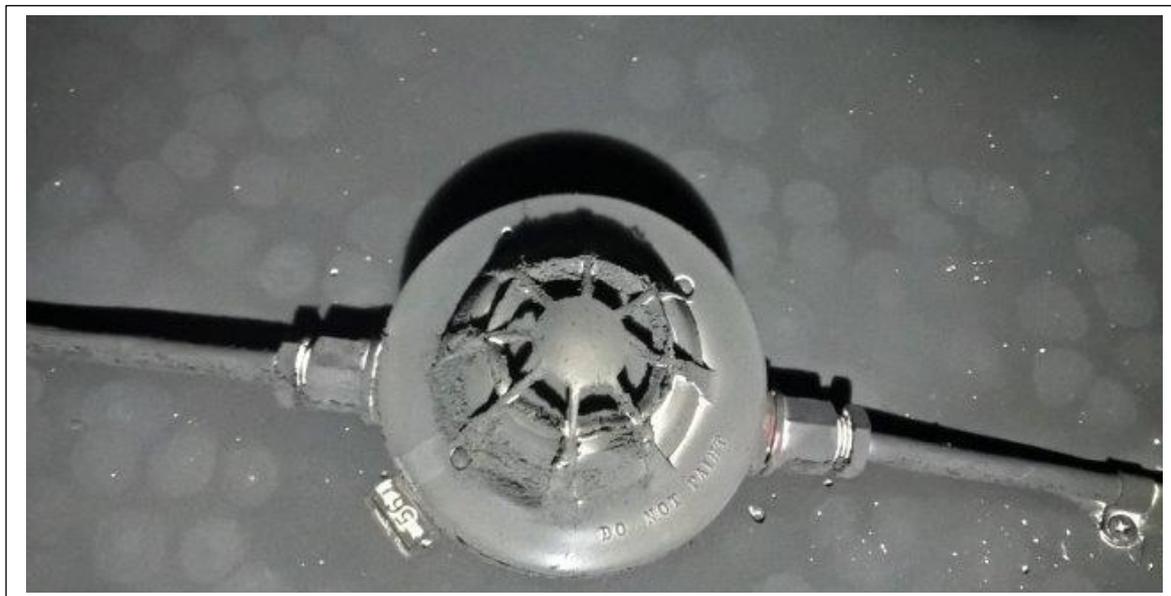
Figure 3.4.5: Photograph of Multi-sensor in Lift Lobby, Stairwell 2, Level 3

However, the photograph below was taken in the lift lobby area of stairwell 2, level 3 and clearly shows the number 56, once the products of combustion had been removed from the identity label.

Notwithstanding, it is reasonable to assume that both these locations indicated on the panel are accurate, as the alarm panel indication of a call point on level 3, outside stairwell 3, was the same location that both LCC staff and a member of the public said that they had actuated the break glass point. Secondly, the lift lobby door at stairwell 2, level 3 was sited close to the fire. This door was repeatedly opened by members of the public and staff, allowing the products of combustion into the lobby area, actuating the multi-sensor.

1. LCC are advised to undertake an audit of fire escape doors at all parking locations, to check compliance to BS5839-3 and BS7273-4.
2. Correctly labelled addressable detectors and call points clearly help the responsible persons and Fire and Rescue Services to reduce the time taken to identify the specific location of alarm actuation. A delay to locating a fire can lead to an escalated incident and potentially more severe fire.
3. Where CCTV is used as part of a fire strategy for detecting a fire, it should fulfil the requirements of BS EN 6276 and BS8418 and have adequate numbers of staff to monitor it. If this is not achievable, then alternative and/or additional detection should be considered.

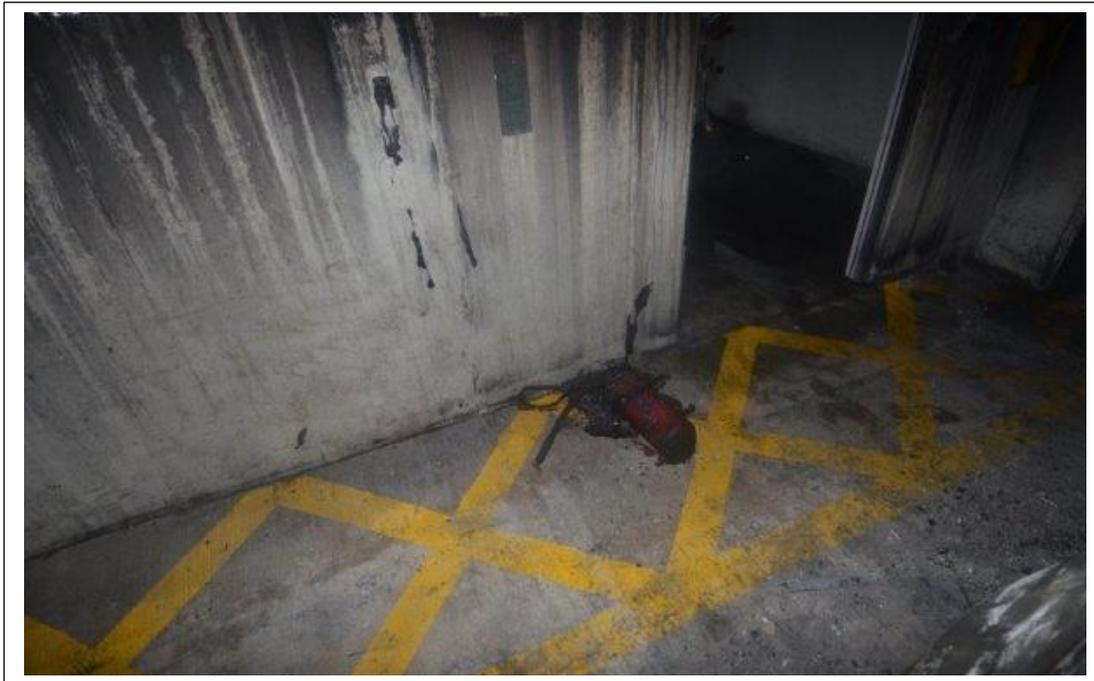
Figure 3.4.8 Remnants of Fire point, Level 3 Stairwell 3

Stairwells 3 and 4 are only available on actuation of the fire alarm. The push bar doors are locked by magnetic devices, linked to the alarm panel. These stairwells are not accessible from outside the car park, for security reasons. Members of the public complained of difficulty in opening the emergency escape door to stairwell 3, level 3.

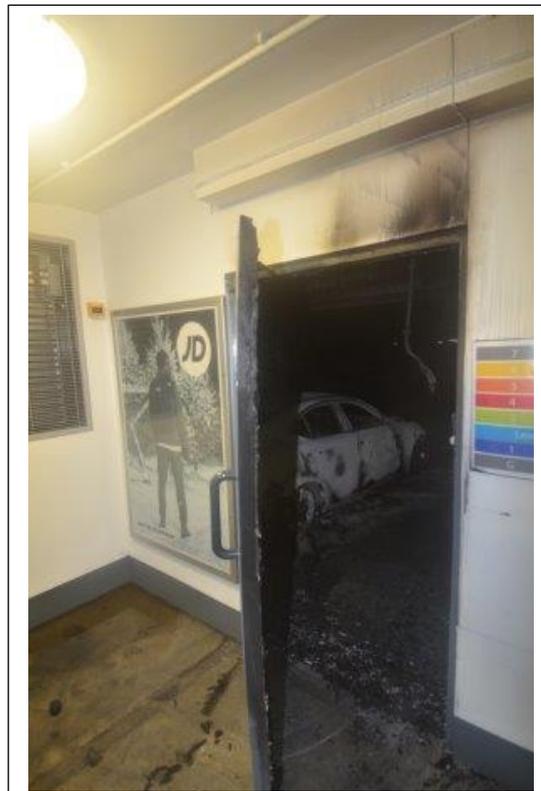
Figure 3.4.9 Stairwell 2 Level 2 exit from parking area

Images 3.4.9 and 3.4.10 are good examples of the effectiveness of the passive fire protection measures in place and how well they performed, despite the severity and intensity of the fire.

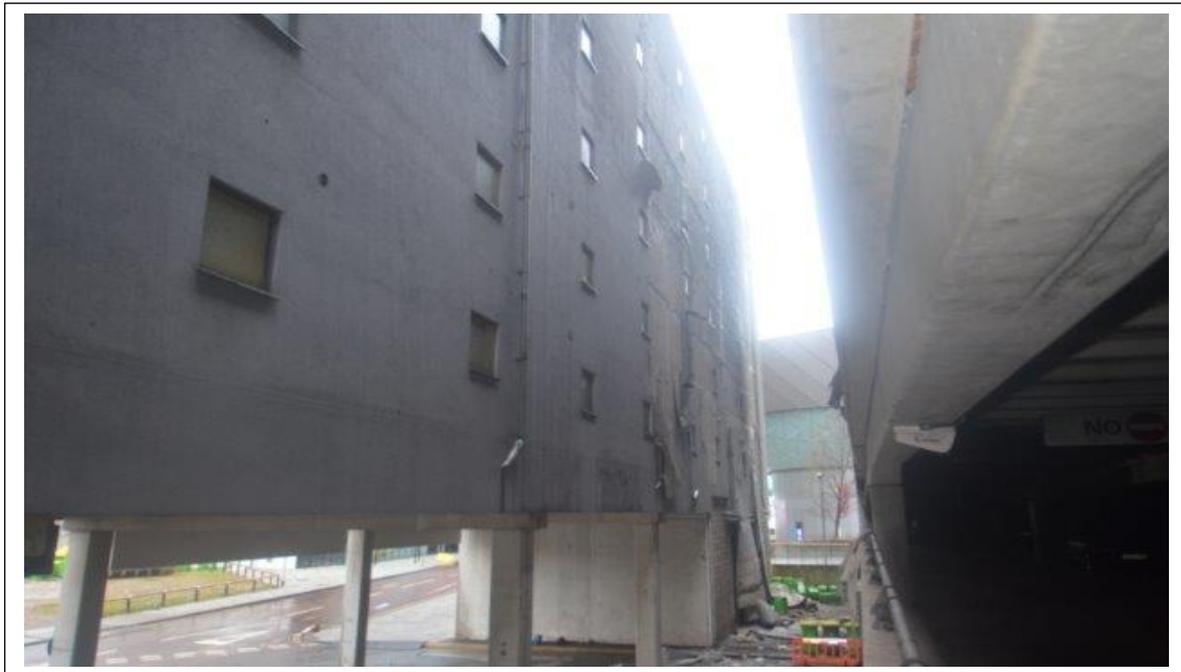
Figure 3.5.1: Firefighting Access on southern elevation

The following images show the severely restricted firefighter appliance access due to the proximity of the serviced apartment building on the southern side of the car park. This negative impact was identified during building regulations submissions and MF&RS insisted on protected stairwells to mitigate this deficiency and accommodate internal firefighting, reaching all levels.

1. Aerial appliance access proved very difficult at this incident and the grilles across the open sides hindered external firefighting. Access and facilities for firefighters at car parks should be reviewed.

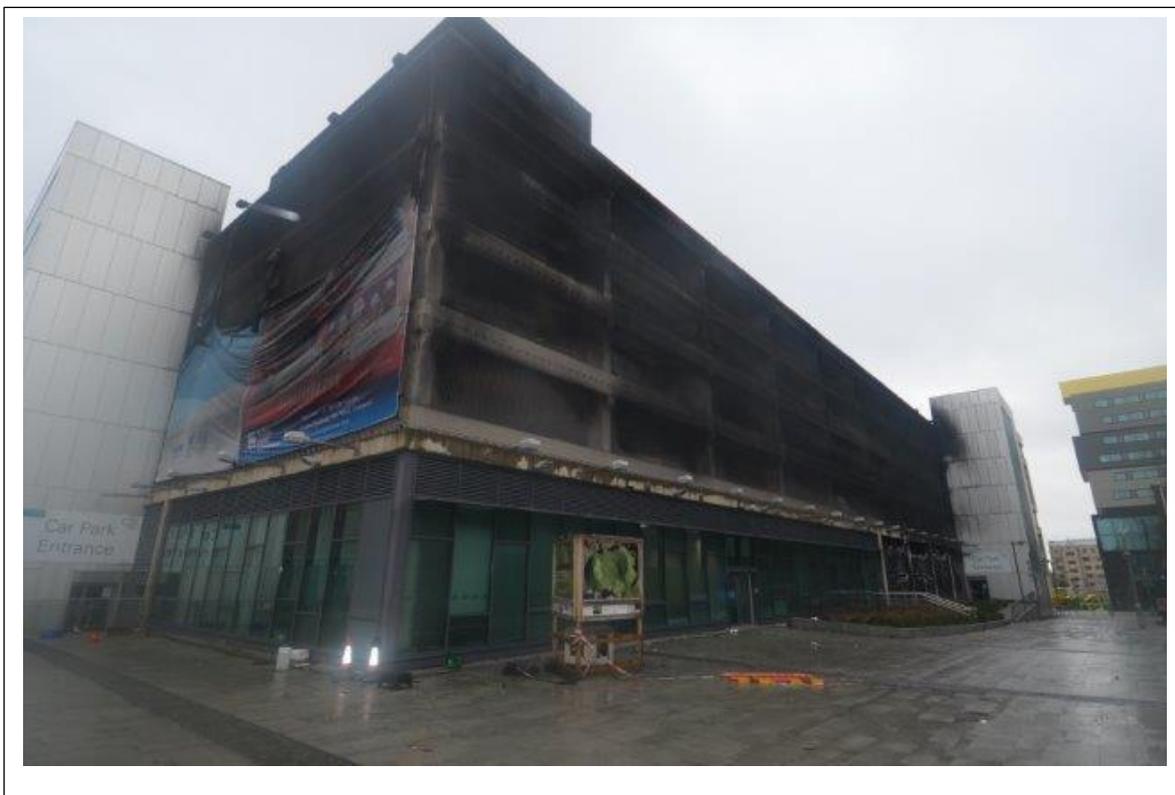
Figure 4.1: Fire damaged advertising hoardings

As can be seen from the above photographs (**Figs. 4.1 & 4.2**), the apertures between columns are covered by grilles. These 'Tigris Woven Mesh Panels' cover the apertures from level 3 to level 6 on the northern and western elevations. The free area of these mesh panels is 65 %, according to GKD UK, the PC-Tigris data sheet. This was taken into account by both LCCLABC and MF&RS in their calculations.

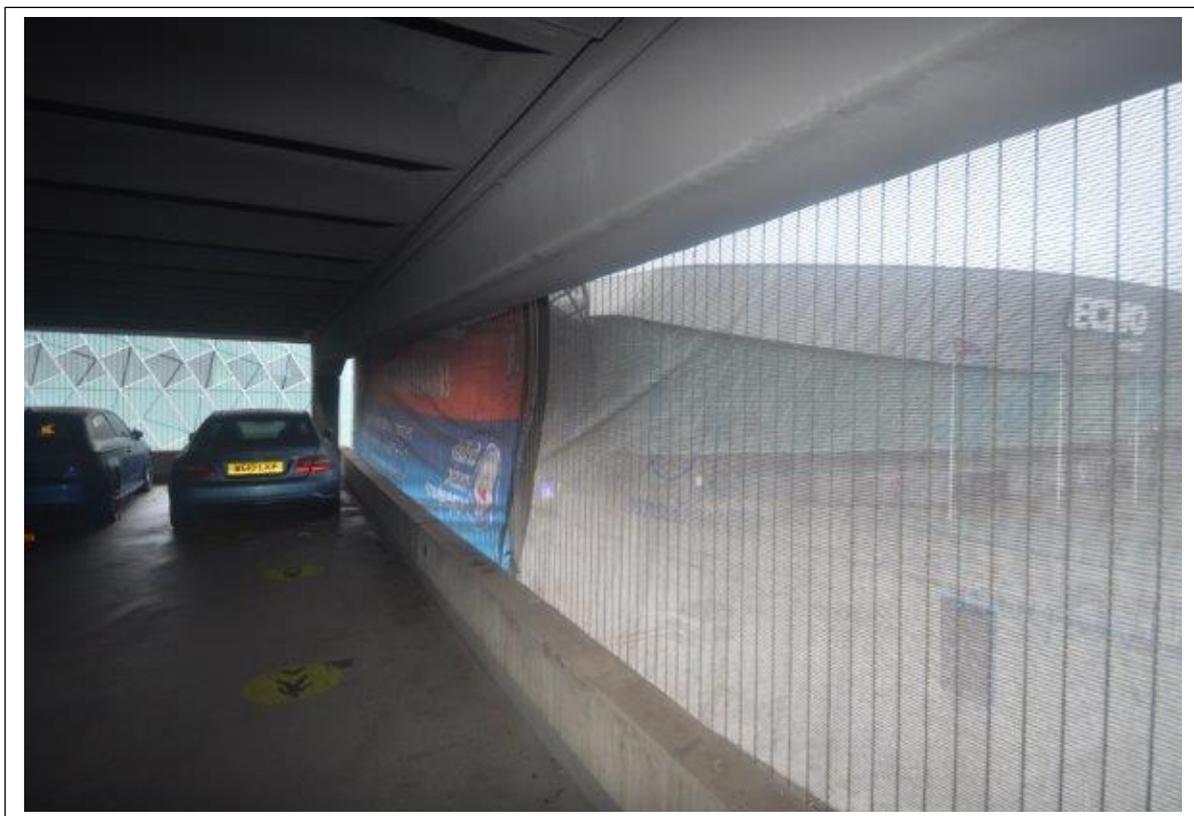
Figure 4.2: Internal view of grille and advertising on level 2

MF&RS took into account an approximate 8% reduction in ventilation caused by the advertising in their calculations and the building still complied with ventilation requirements under ADB Vol.2.
