# SIGNIFICANT INCIDENT REPORT (Final)

Incident: 033394-31122017

Address: Kings Dock Car Park

Date: 31<sup>st</sup> December 2017

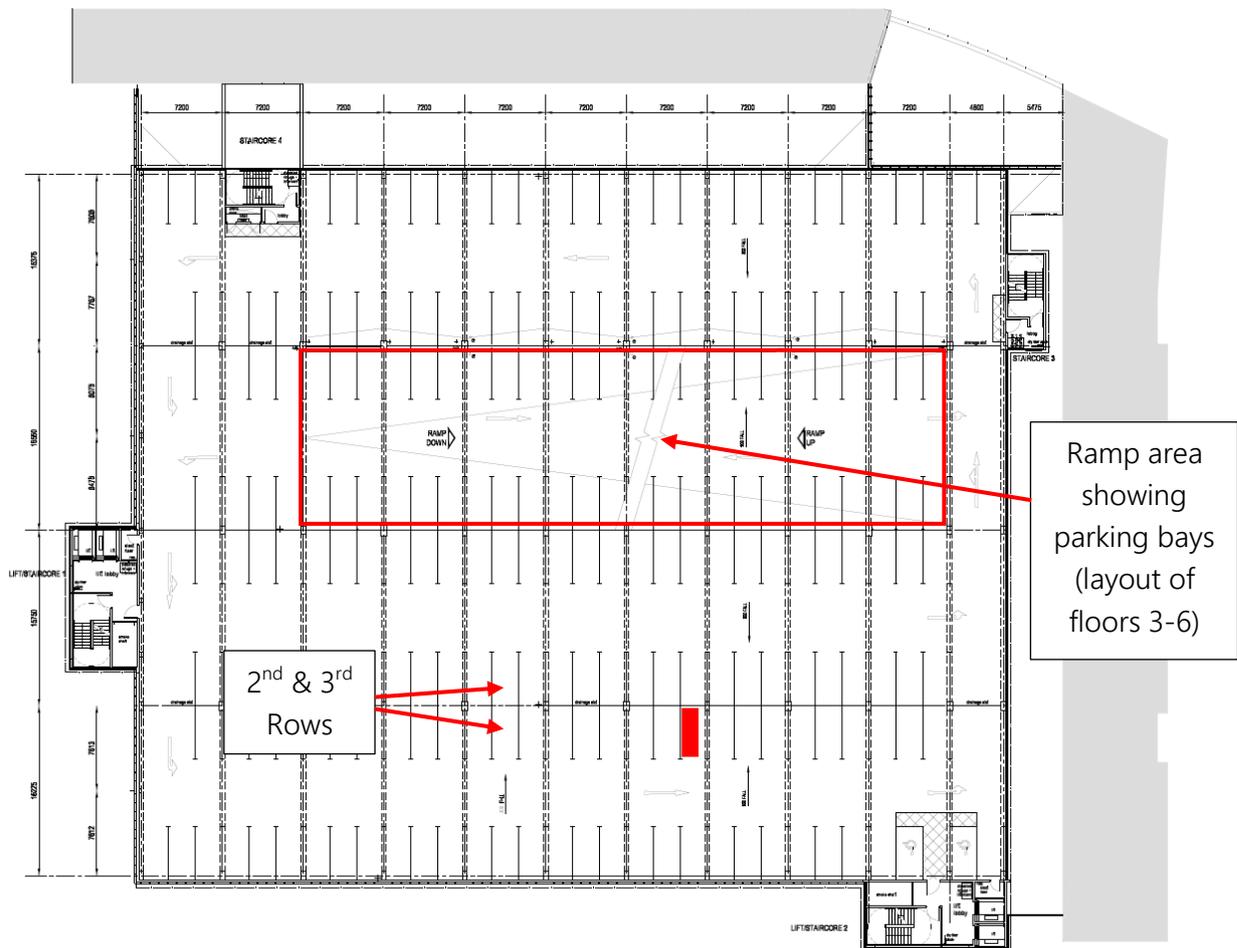
From initial observations, CCTV and Social Media sources it could be seen that the fire once sufficiently developed moved rapidly up through the structure. Early thoughts around this highlighted vehicles being parked on the ramps between floors as a possible factor in fire spread.

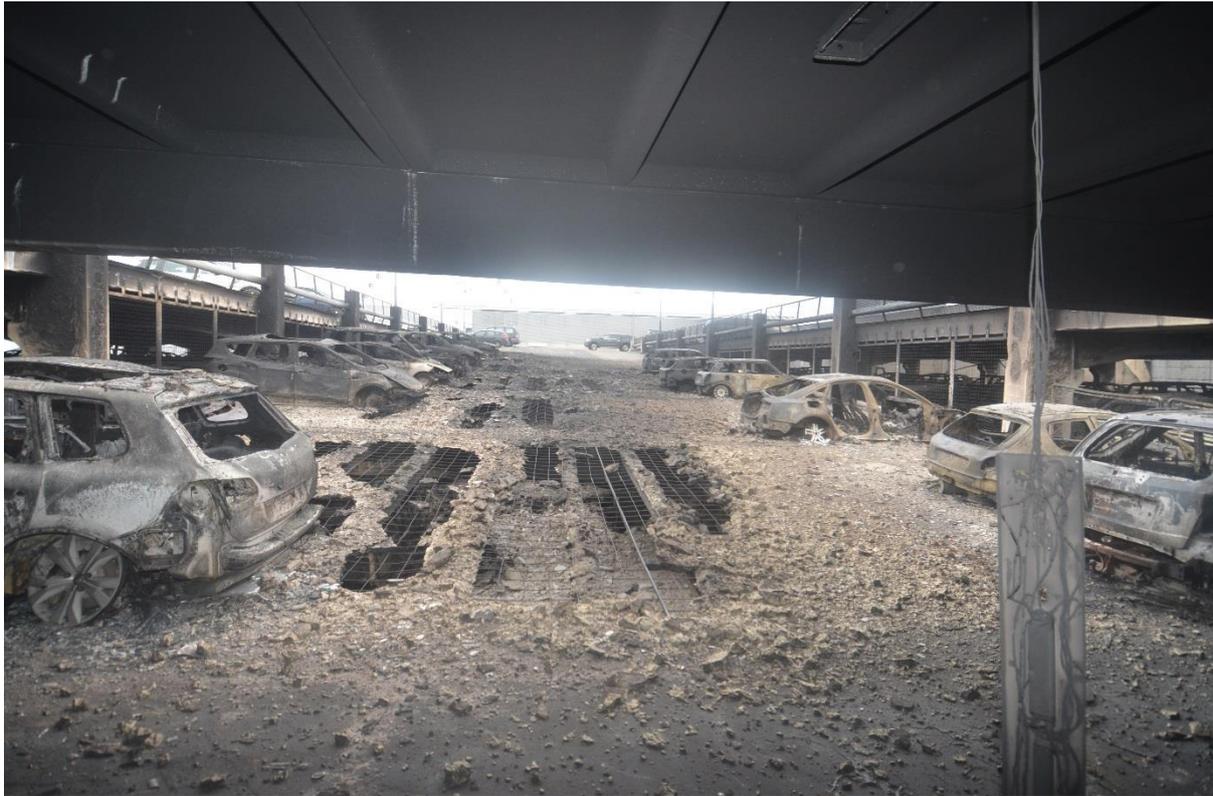
Next it was considered whether the failure of the concrete structure itself had been a major factor in fire spread. BA teams and personnel externally, reported spalling or exploding concrete, with BA teams identifying holes in the floor above or seeing debris falling down. Later BA teams also reported ignited fuel running down like a waterfall from the floor above.

Images obtained by IIT show severe failure of the concrete floors.

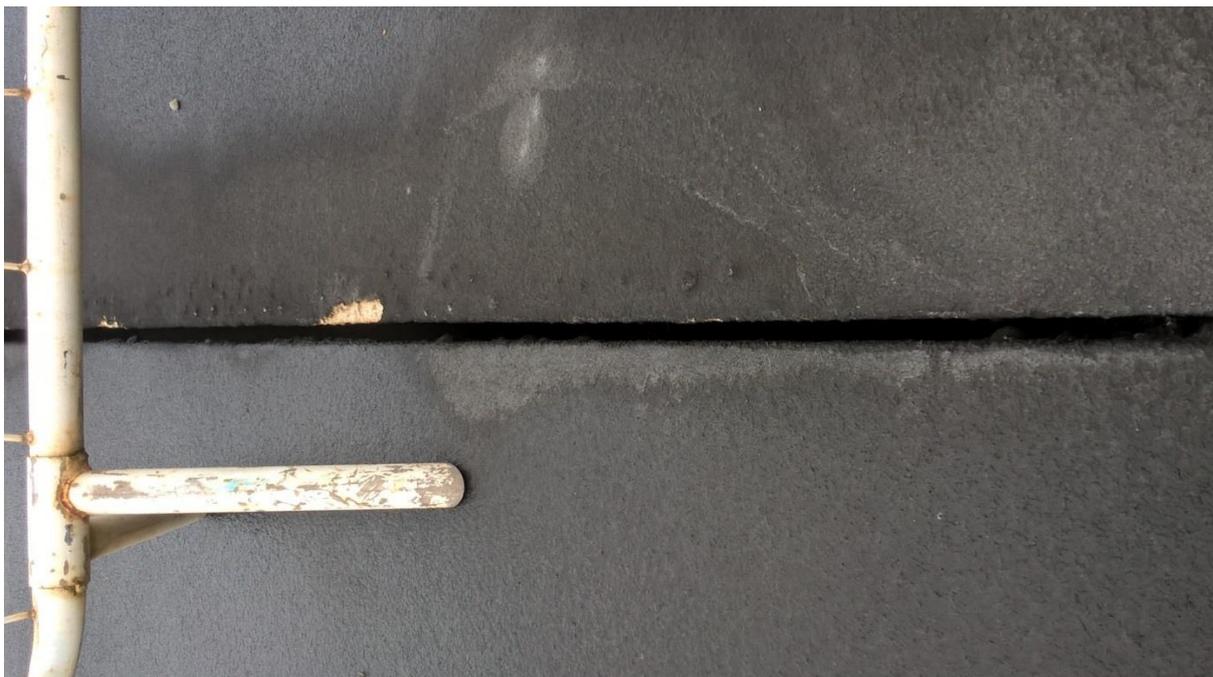
The investigation has shown a drainage system built into the car park floor to take away any excess surface water. The drainage systems vary on different parts of the floor level, i.e. the drains adjacent to the ramps are different to those adjacent to where the car that first ignited was situated. This is an area also highlighted within the MFRS Protection Report and is considered as a cause of fire spread between floors.

The image below shows a view of the drainage slot from above.

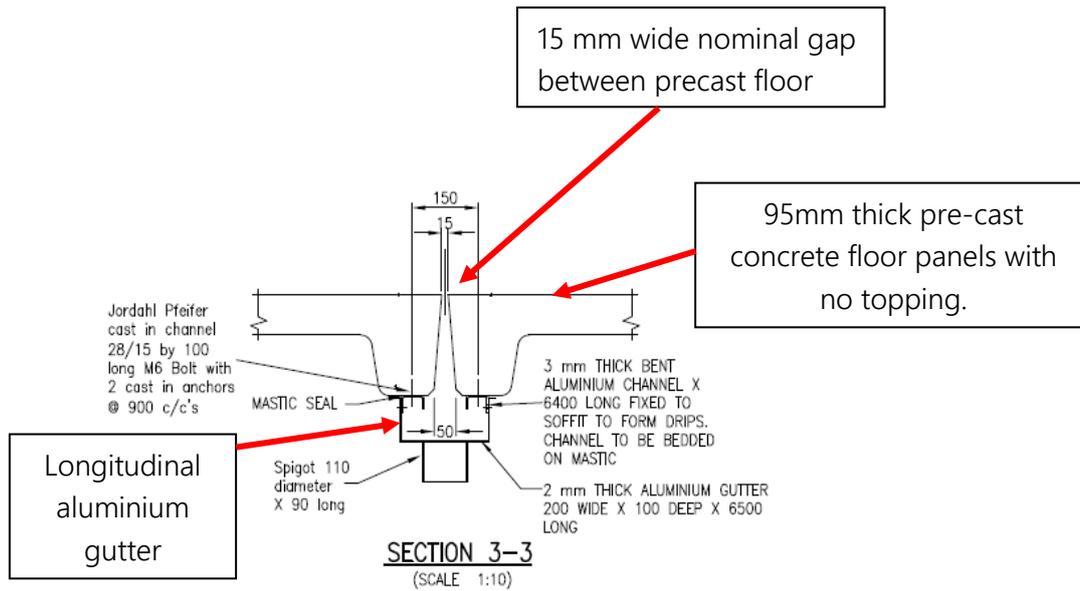
Extract from Level 2 Structural GA drawing 04248/15

This drainage slot runs between columns with two rows of three cars parked between each column. The drawing below shows the shape of the slot and the guttering below.

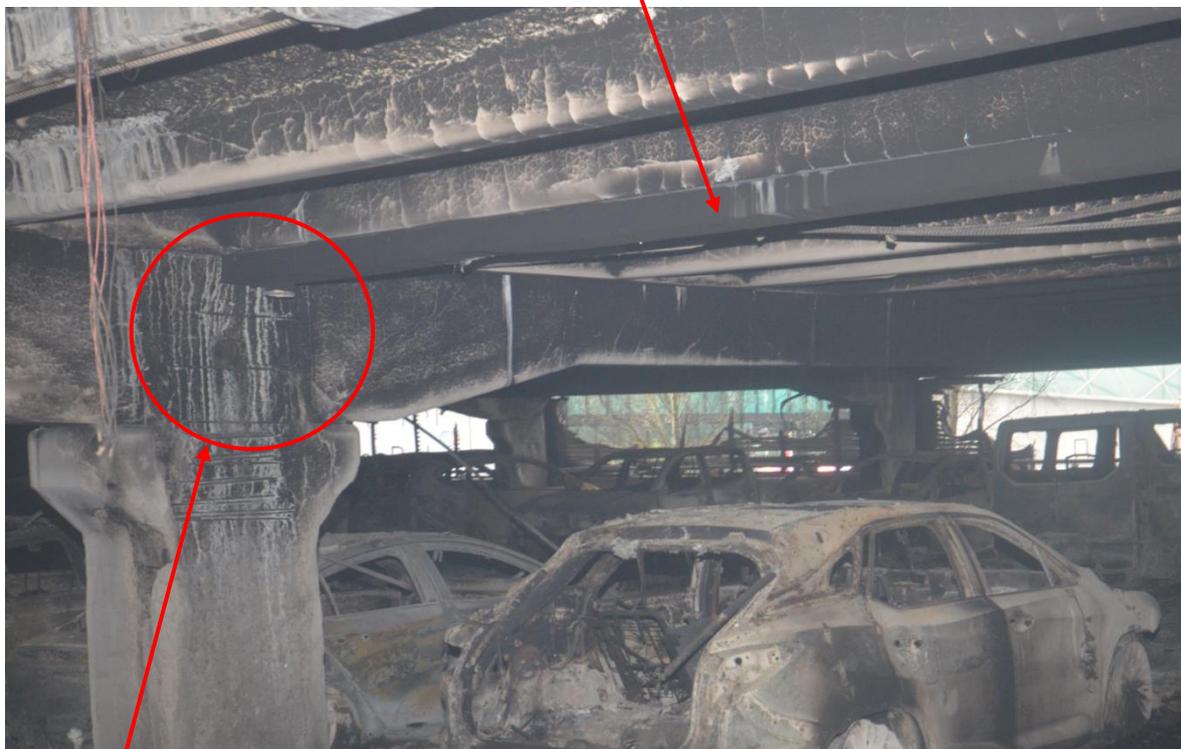
Image below shows a section of aluminium guttering in place.

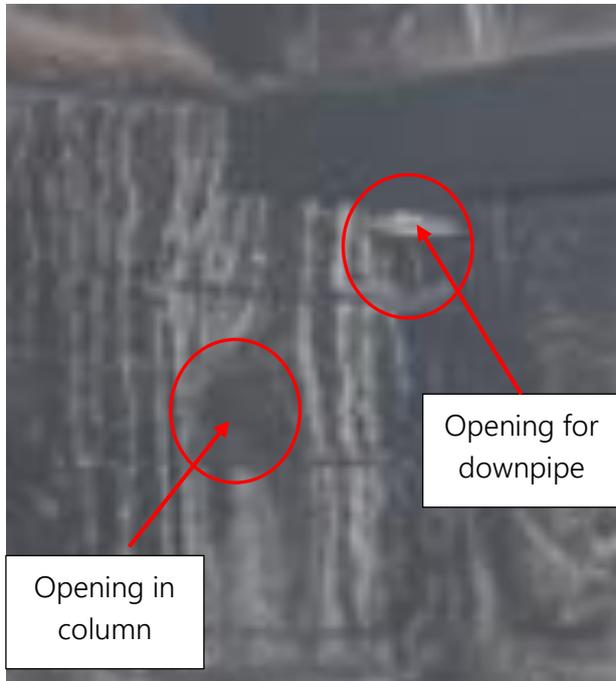
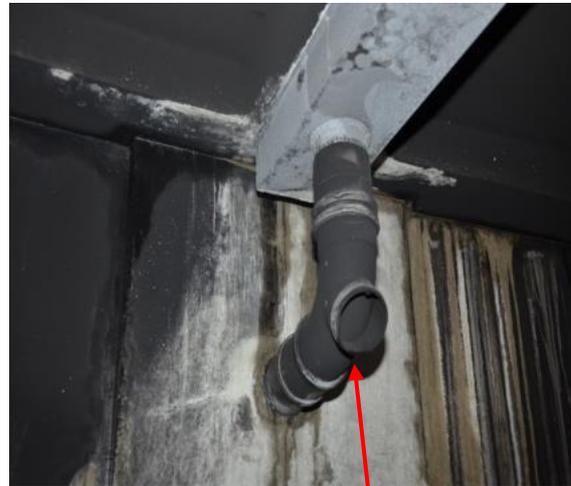
Image with downpipe still in situ

The image below shows a close up of a section of the aluminium guttering still in situ. The design provides a hole in the guttering where a plastic downpipe would have carried surface water out of the guttering. There is also a hole in the concrete column which the downpipe may have run into or the adjacent guttering from the other side of the column would have come through the column at this point.

The plastic pipework and/or the guttering is likely to have failed, allowing the travel of heat and flame upwards and allowing running fuel fires to run back down to the floor below.

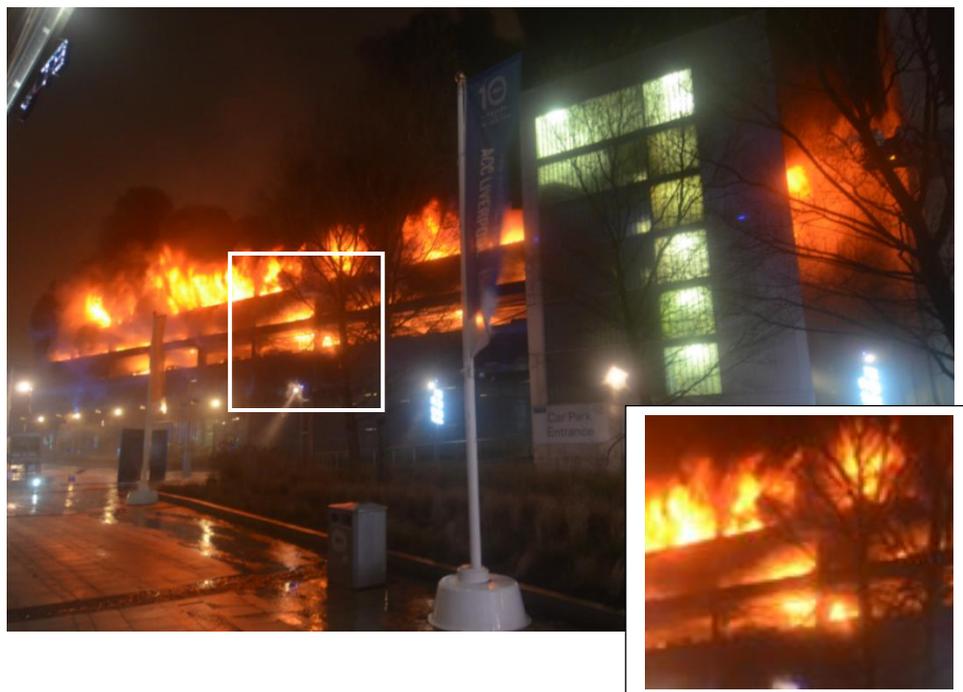
The image below shows an intensity of fire and heat in the lower floors where compartmentation is possibly breached, whether by effects of fire and heat on the concrete or possibly due to the drainage design.

From the evidence gathered it is likely that the construction of the drainage system and subsequent failure at the high temperatures during the fire, contributed to the fire spreading above and below the level of origin.
