KINGS DOCK CAR PARK FIRE

PROTECTION REPORT

April 2018

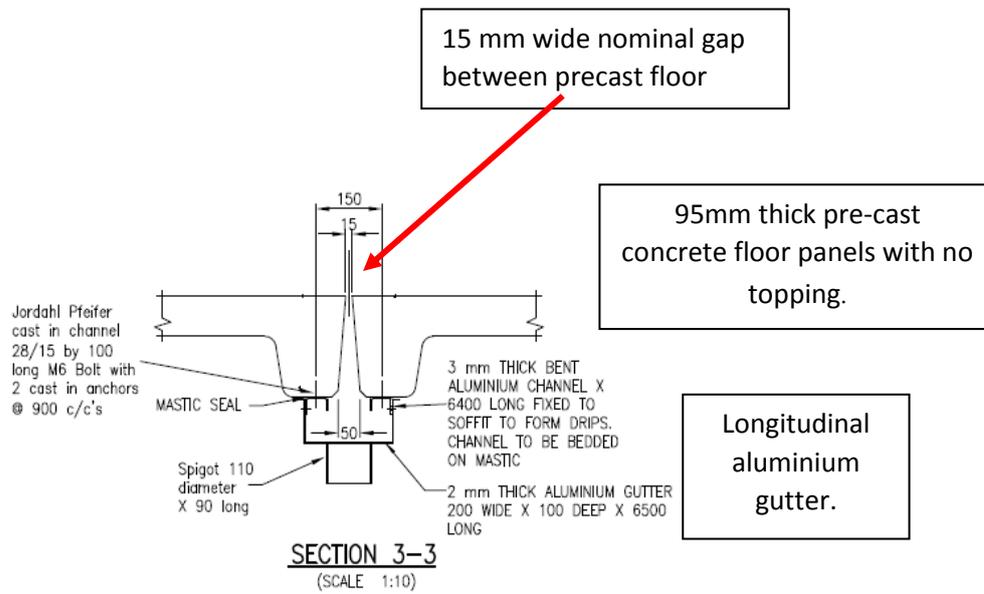
Figure 2.2.3: Extract from Level 2 Structural GA drawing 04248/15

This drainage slot runs between columns with two rows of three cars parked between each column (see fig.2.1).

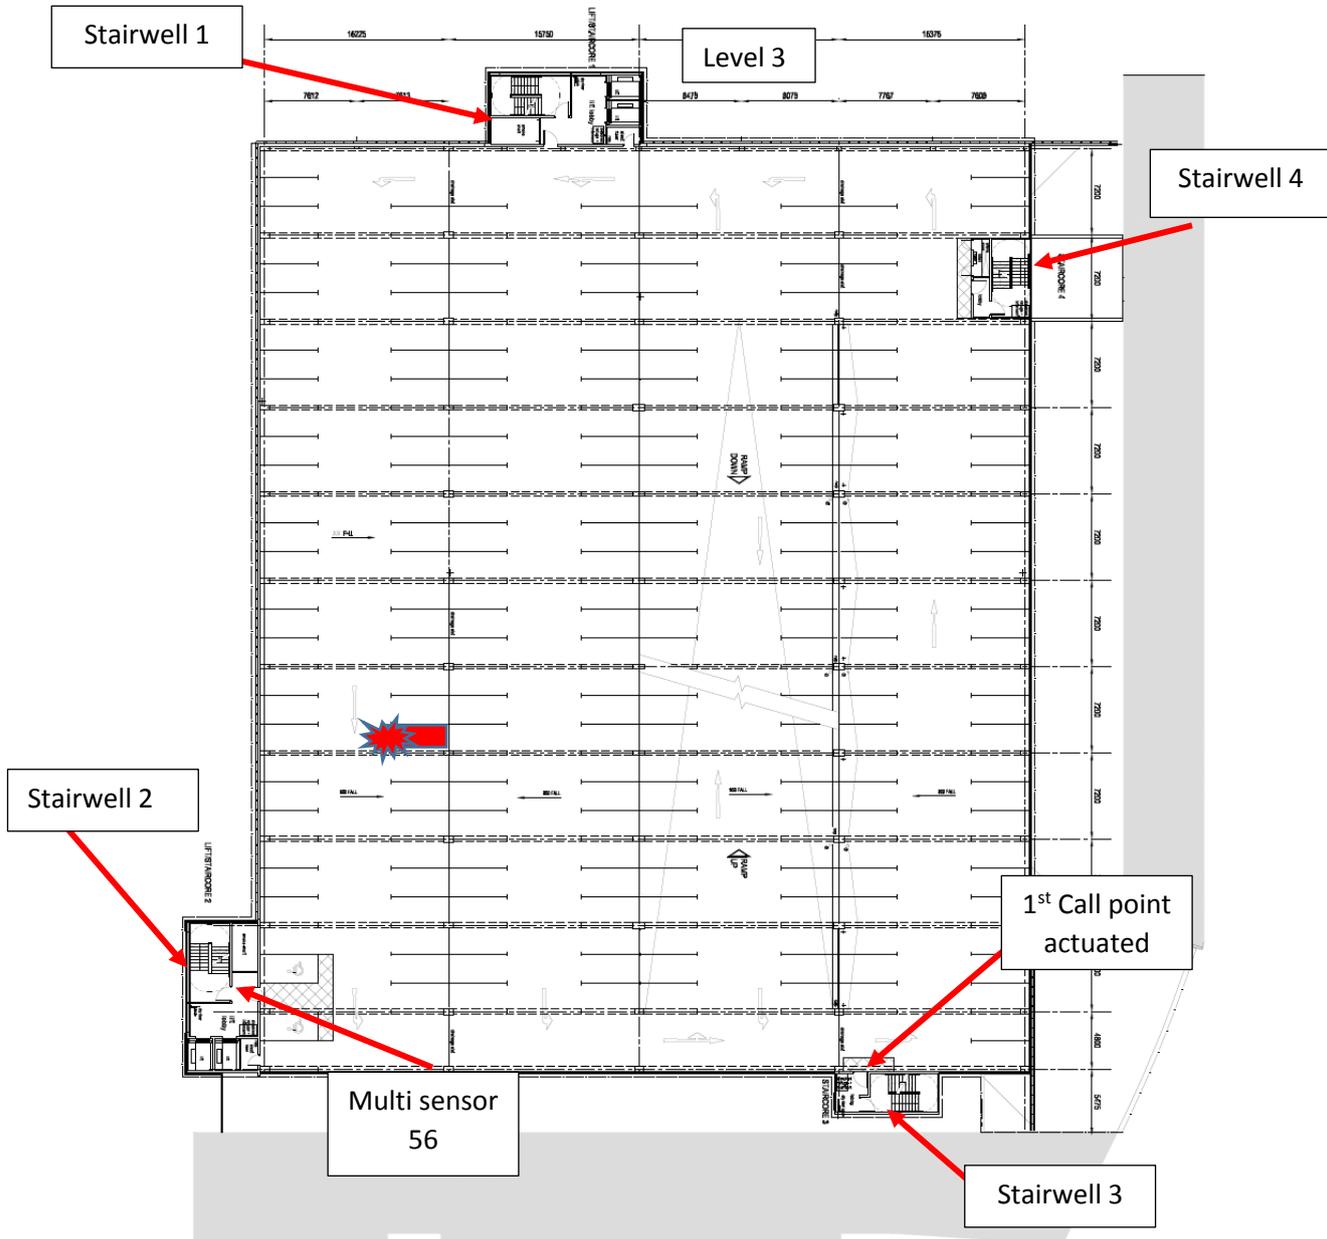
Figure 3.4.1: Level 3 floor plan

The fire alarm was first actuated at 16:43:49, alarm panel indicating call point 64, level 3, adjacent to escape stairwell 3.

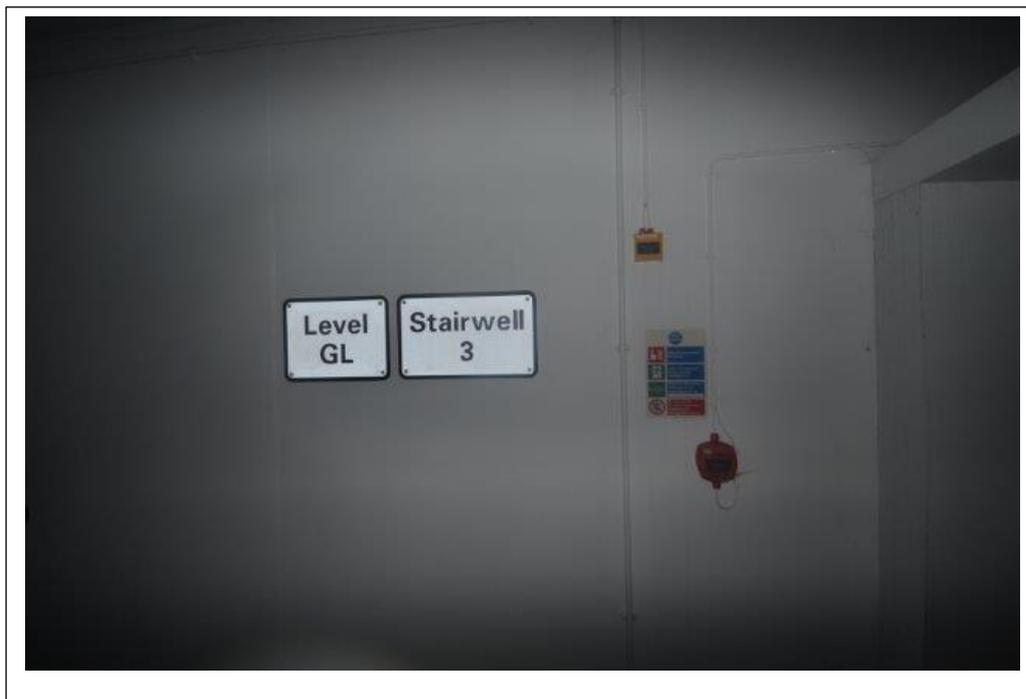
Figure 3.4.6 Active Protection Measures, ground floor, Stairwell 3

The protected stairwells have dry risers, automatic openable vents with manual overrides, automatic detection on all levels refuge points with communications and manual call points are sited adjacent to final exits.

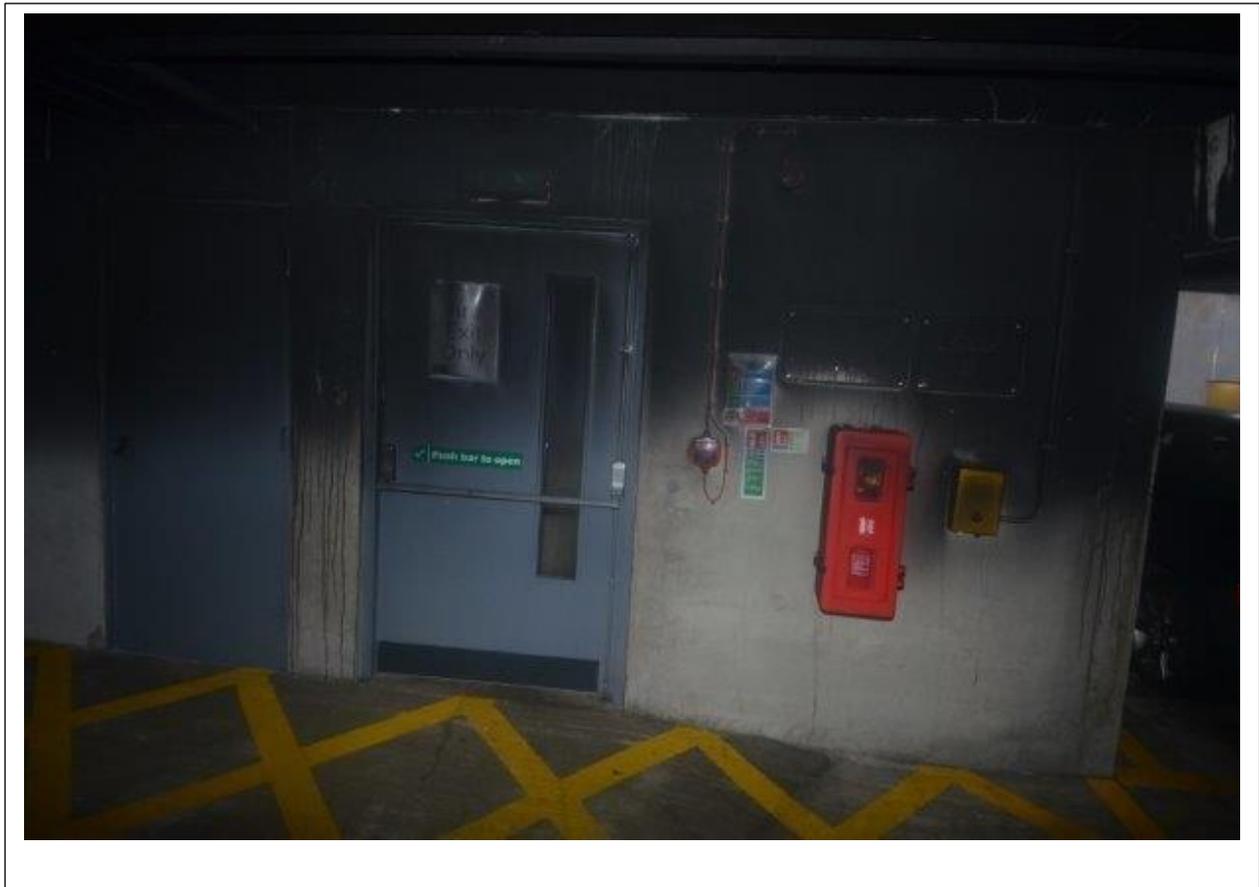
Figure 3.4.7 Fire point and exit, Level 1 Stairwell 4

Fire extinguishers are located adjacent to call points on all levels and additional firefighting equipment and a fire event team were provided by WH Management during the event. The remit of the event firefighting team within the car park did not extend beyond the stabled area on the ground floor.

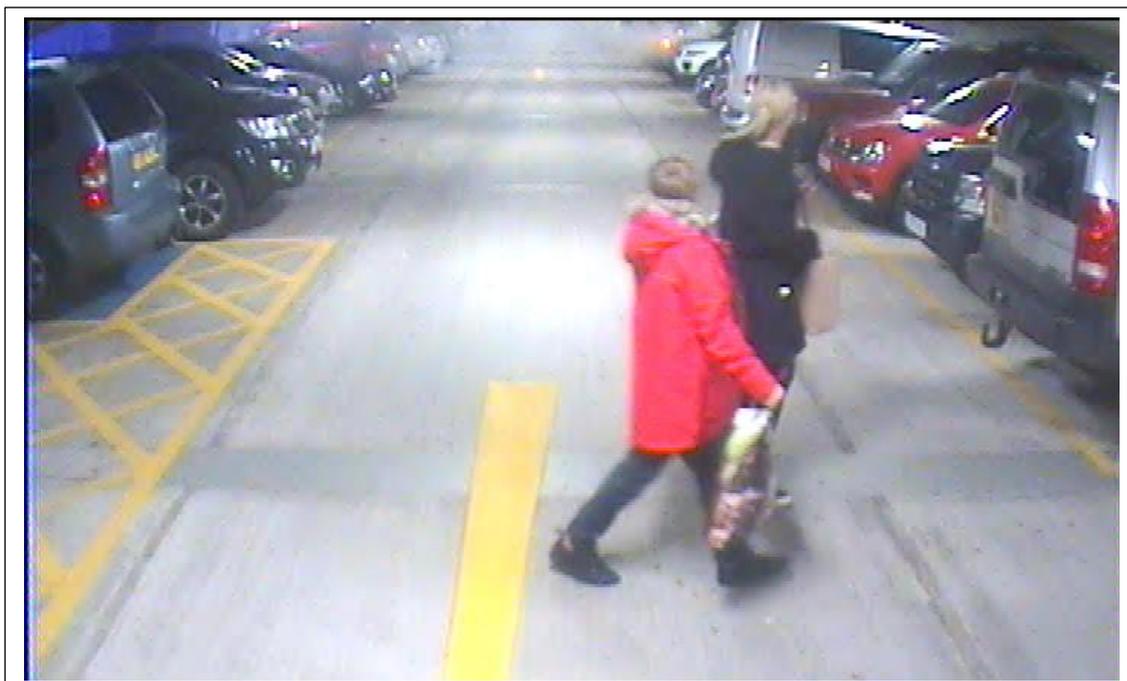
Figure 5.1.1: CCTV still frame

The CCTV images below (**Figure 5.1.1**) was taken just before first 999 call. None of these witnesses called 999 or raised the alarm and the image overleaf (**Figure 5.1.2**) captures the event approximately 3 minutes prior to 999 call.

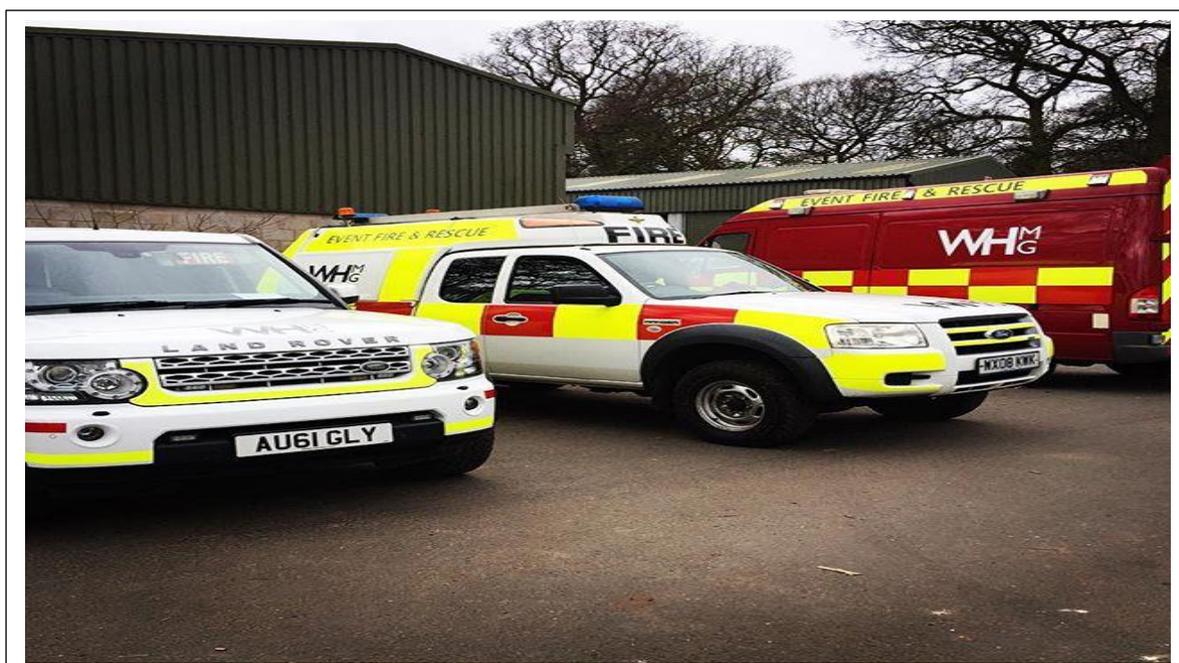
Figure 5.1.3: WH Management Emergency Response vehicles

An “Event Firefighting Team” was in attendance by 16:45hrs. They parked outside the main entrance to the car park, in a vehicle which had blue flashing lights and “fire & rescue” livery. This may have led members of the public to believe that MF&RS were in attendance and reduced number of 999 calls.
