# SIGNIFICANT INCIDENT REPORT (Final)

Incident: 033394-31122017

Address: Kings Dock Car Park

Date: 31<sup>st</sup> December 2017

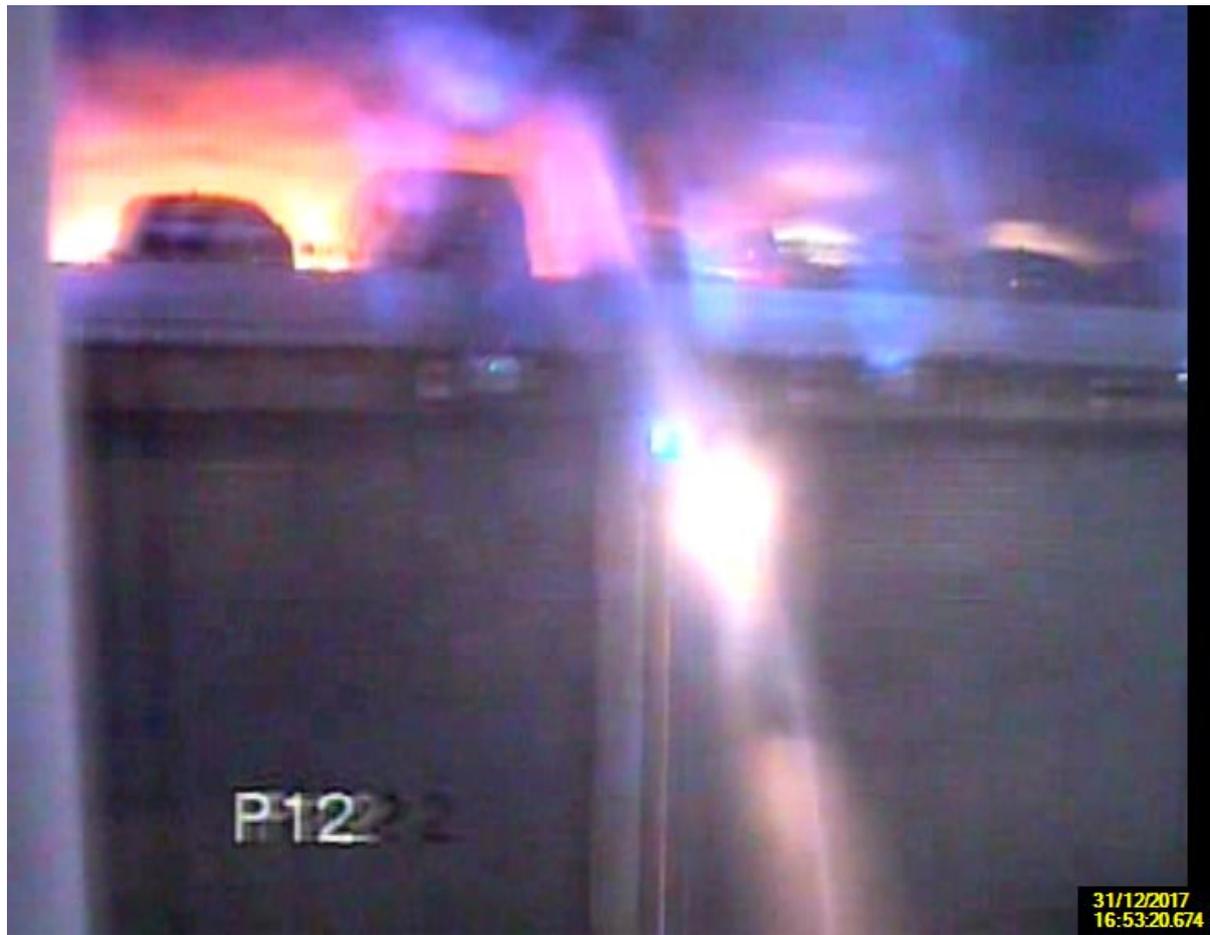
1711hrs – Two main branches deployed

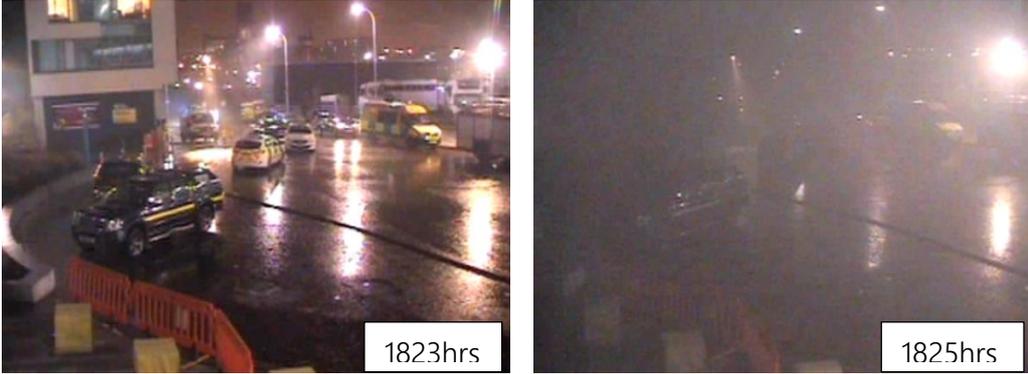
18:25	Smoke black out of external area captured by CCTV by the Pullman Hotel following an escalation or change in fire conditions inside the car park

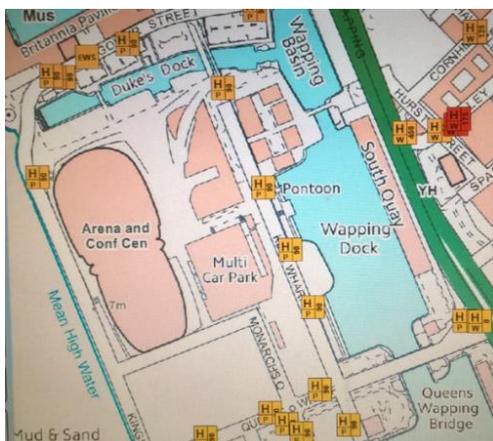
MFRS MDT Hydrant Overlay

An upgrade to the hydrant software was planned in 2018 which provides access to all hydrants plus water main routes and sizes. The differences between the two overlays can be seen below;

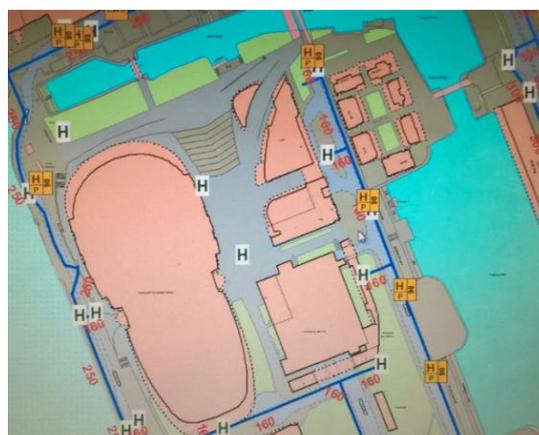
UU & MFRS Combined MDT Hydrant Overlay

Initial water supplies appear to have been sufficient to supply three main jets in Sector 2 (Stair Core 2). Water supplies began to overrun once a second sector was opened (Sector 3 Stair Core 1). This is now known to be attributed to water supplies being sourced from the same ring main, albeit they were physically separated by some distance. This water ring main runs around the Kings Dock estate and is a 250mm main with branches of 160mm running off it. Both initial Sectors were set into hydrants on the 160mm branches.
